Project No.: 25244
Date: April 1st, 2026
Tender No: RFT #2026-OPS-01
Project: **The Corporation of the Town of Deep River
Deep River Arena Complex Rink Slab Replacement**

Designated Substances Survey & Report Asset Retirement Obligations

Deep River Arena
2 Club House Road, Deep River, ON

BCE Project: 24-1445.r1
Report Issued: April 17, 2025

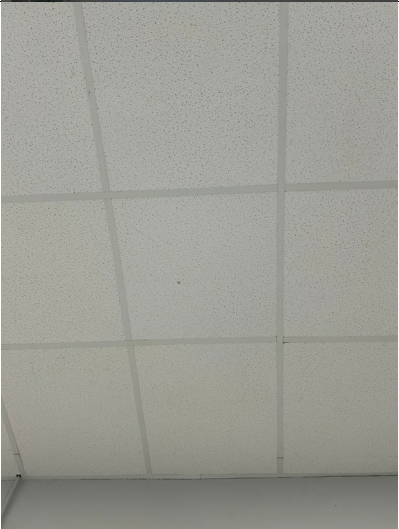
<p>Representative view of 60cm x 60cm acoustic ceiling tile (small and medium pinholes) (2-AS-02 A-C) observed throughout the 1st Floor viewing area. It was found not to contain asbestos.</p>
3

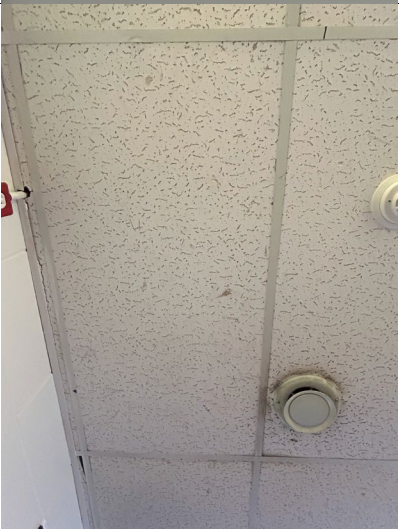
<p>Representative view of 60cm x 120cm acoustic ceiling tile (small pinhole with width-wise fissures) (2-AS-03 A-C) observed within the dressing room corridor. It was found not to contain asbestos.</p>

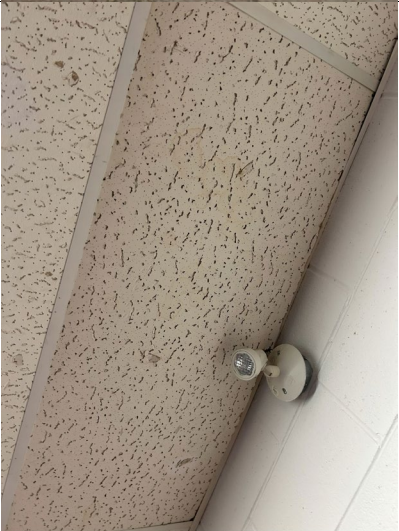
<p>Representative view of 60cm x 120cm acoustic ceiling tile (small pinholes with length-wise fissures) (2-AS-05 A-C) observed within Dressing Room 6. It was found to contain 1% Chrysotile asbestos.</p>
6	 	<p>Representative view of concrete block mortar (2-AS-06 A-C) observed within the First Aid Room. It was found not to contain asbestos.</p>

Asbestos-Containing Material	Material Location	Recommendations
Acoustic Ceiling Tiles (60cm x 120cm - Small Pinholes with Lengthwise Fissures)	Dressing Room 6 & Maintenance Room	Remove/disturb following Type 1 operations if less than 7.5 m ² is disturbed without damaging materials and materials are wetted. Remove/disturb following Type 2 operations if more than 7.5 m ² is disturbed without damaging materials and materials are wetted. *See O. Reg. 278/05 for other operations and procedures if water cannot be used and/or power tools must be used.

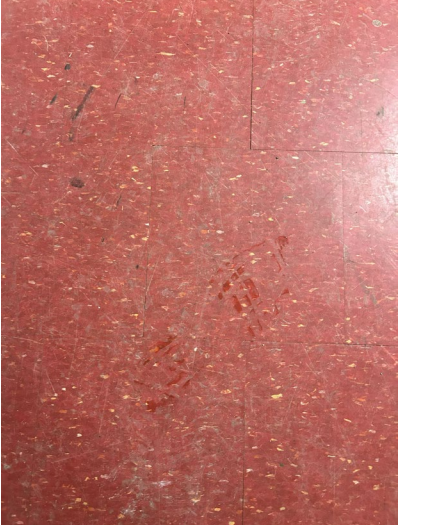
Photo #		Material Location / Description
7

<p>Representative view of 30cm x 30cm vinyl floor tile (red with white streaks) (2-AS-07 A-C) observed within the 2nd Floor Staff Room. It was found not to contain asbestos.</p>
8

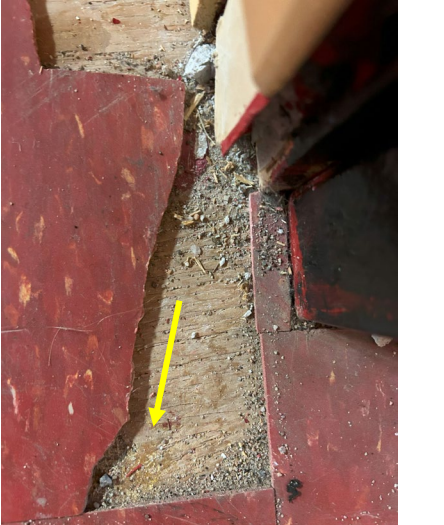
<p>Representative view of yellow vinyl floor tile mastic (yellow arrow) (2-AS-08 A-C) observed within the 2nd Floor Staff Room. It was found not to contain asbestos.</p>
9

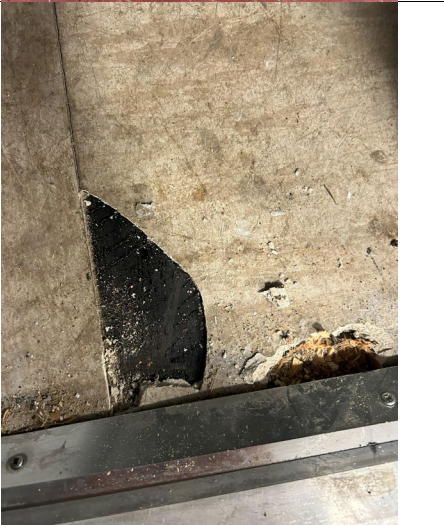
<p>Representative view of 30cm x 30cm vinyl floor tiles (grey with white streaks) and associated brown mastic (2-AS-09 A-C) observed within the 2nd Floor Exit Stairwell. The vinyl floor tile was found to contain 2% Chrysotile asbestos while the brown mastic was found not to contain asbestos.</p>

Asbestos-Containing Material	Material Location	Recommendations
Vinyl Floor Tiles (30cm x 30cm Grey with streaks)	Exit Stairwell from 2 nd Floor Hall	Remove following Type 1 operations if non-powered hand tools and water are used. *See O. Reg. 278/05 for other operations and procedures if water cannot be used and/or power tools must be used.
Texture Ceiling Coat (PACM)	Arena Viewing Area, 1 st Floor	Remove following Type 3 operations if more than one square meter of material will be removed. *See O. Reg. 278/05 for other operations and procedures if less than one square meter is removed.

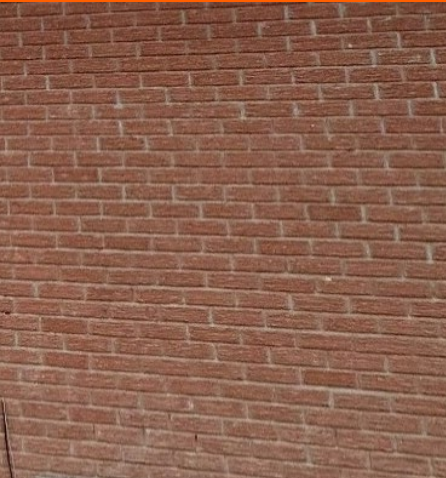
Photo #		Material Location / Description
10

<p>Representative view of brick mortar (2-AS-11 A-C) observed within the exterior of the building. It was found not to contain asbestos.</p>
11

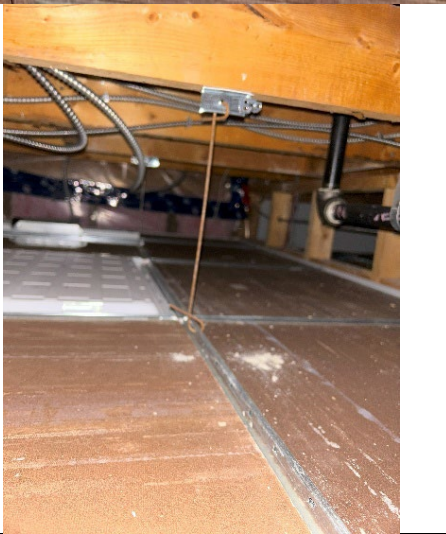
<p>Representative view of ceiling space with uninsulated mechanical systems.</p>
12

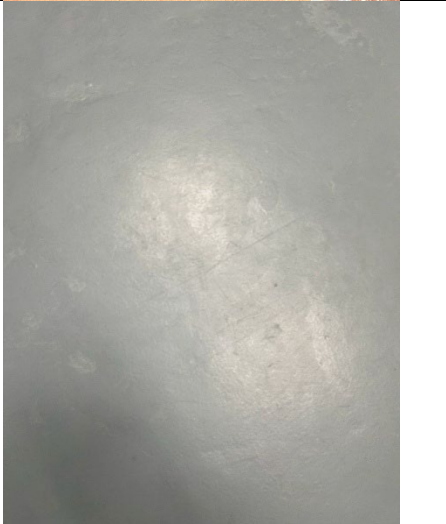
<p>Representative view of the dark grey floor paint (2-LS-01) observed within the 1st floor viewing area. It was found to contain lead concentrations below the EACC guideline limit.</p>

- Although the dark grey floor paint, red wall paint, blue wall paint, light blue wall paint, ceramic tile, beige wall paint, and light grey floor paint finishes were identified under the 1,000 µg/g lead content limit, precautions around its abatement are recommended if the material is to be disturbed. A risk assessment must be conducted if the paint is to be disturbed in a non-aggressive manner to determine what control procedures must be put in place (e.g. dust suppression, PPE, washing facilities for workers). If the material is to be disturbed in an aggressive manner, work must follow the MLITSD Guidelines - *Lead on Construction Projects* and/or the *EACC Lead Guideline for Construction, Repair, Renovation, Maintenance or Repair*. In addition to normal dust control, this may include use of HEPA-filter vacuums and appropriate respirators.

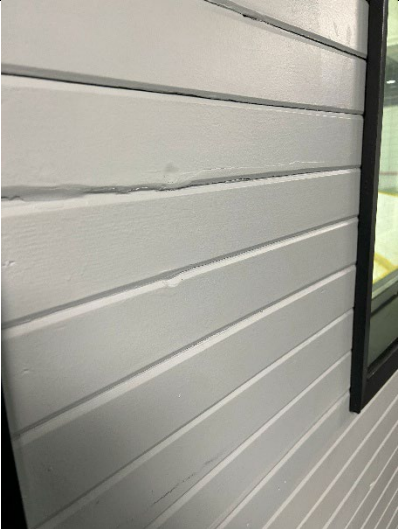
Photo #	Material Location / Description	
13

<p>Representative view of white wall paint (2-LS-02) observed within the 1st floor viewing area. It was found to contain lead concentrations below the method detection limit.</p>
14

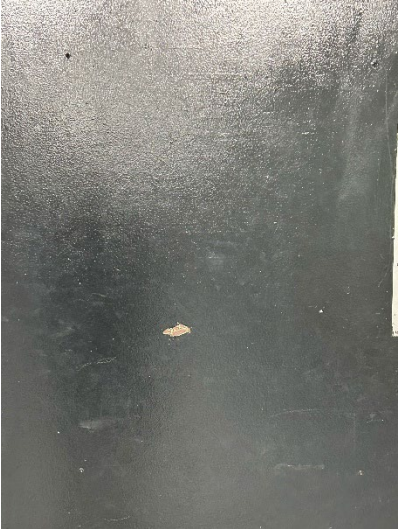
<p>Representative view of black door paint (2-LS-03) observed within the 1st floor viewing area. It was found to contain lead concentrations below the method detection limit.</p>
15

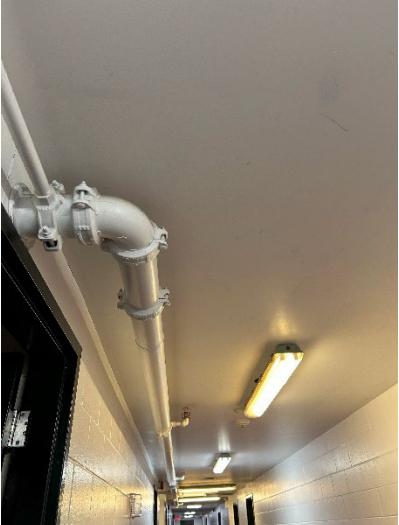
<p>Representative view of white wall ceiling (2-LS-04) observed within the 1st floor corridor. It was found to contain lead concentrations below the method detection limit.</p>

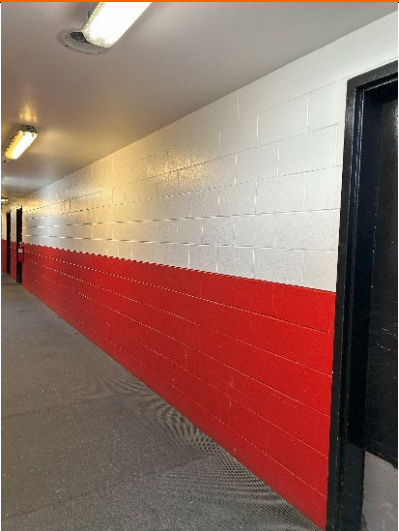
Photo #		Material Location / Description
16

<p>Representative view of red wall paint (2-LS-05) observed within the 1st Floor Corridor. It was found to contain lead concentrations below the EACC guideline limit of 1,000 ug/g.</p>
17

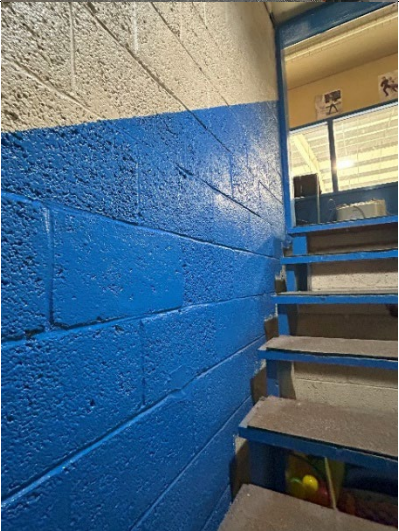
<p>Representative view of blue wall paint (2-LS-06) observed within the skating club office. It was found to contain lead concentrations below the EACC guideline limit of 1,000 ug/g.</p>
18

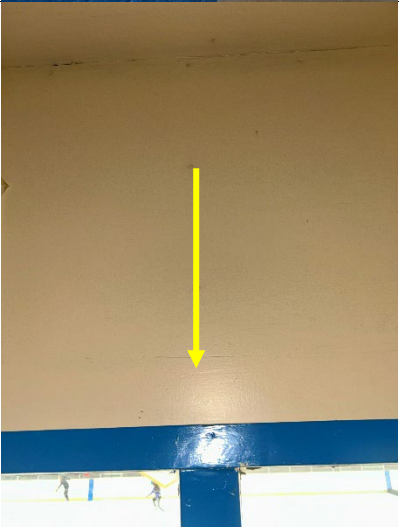
<p>Representative view of light blue wall paint (yellow arrow) (2-LS-07) observed within the 2nd floor Skating Club Office. It was found to contain lead concentrations below the EACC guideline limit of 1,000 ug/g.</p>

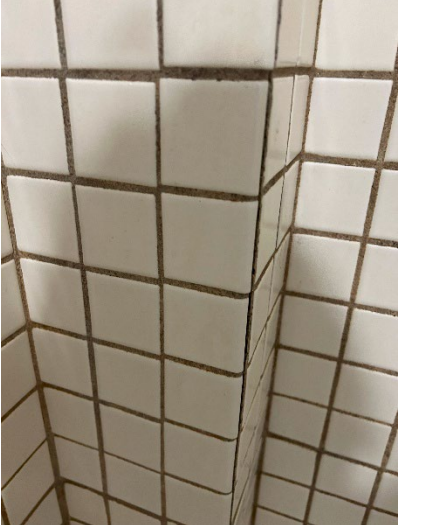
Photo #		Material Location / Description
19

<p>Representative view of ceramic tile (2-LS-08) observed within the showers of Dressing Room 6. It was found to contain lead concentrations below the EACC guideline limit of 1,000 ug/g.</p>
20

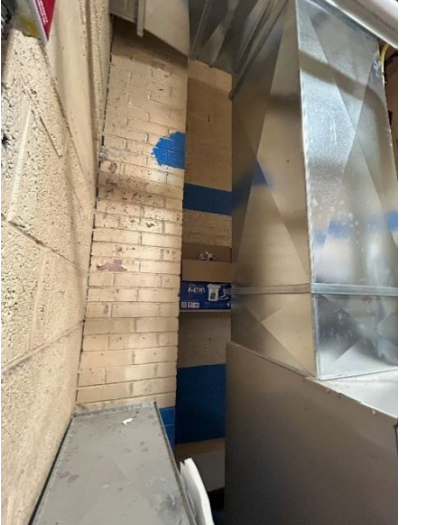
<p>Representative view of beige wall paint (2-LS-09) observed within the first aid room. It was found to contain lead concentrations below the EACC guideline limit of 1,000 ug/g.</p>
21

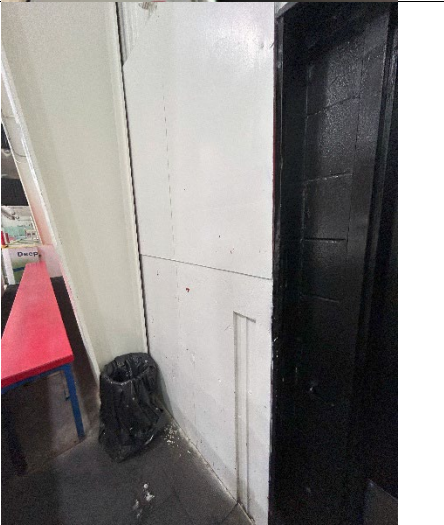
<p>Representative view of white wall paint (2-LS-10) observed within the Arena. It was found to contain lead concentrations below the EACC guideline limit of 1,000 ug/g.</p>

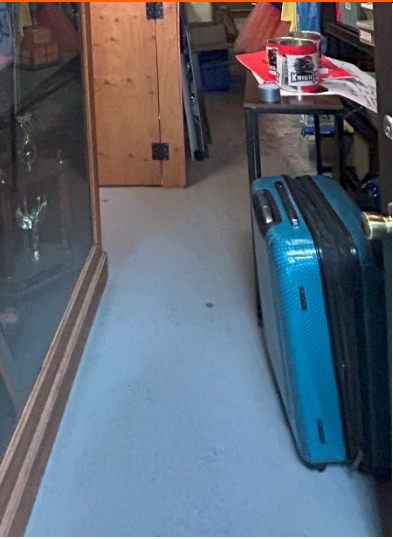
Photo #	Material Location / Description	
22

<p>Representative view of light grey floor paint (2-LS-11) observed within the 1st Floor storage room. It was found to contain lead concentrations below the EACC guideline limit of 1,000 ug/g.</p>
23

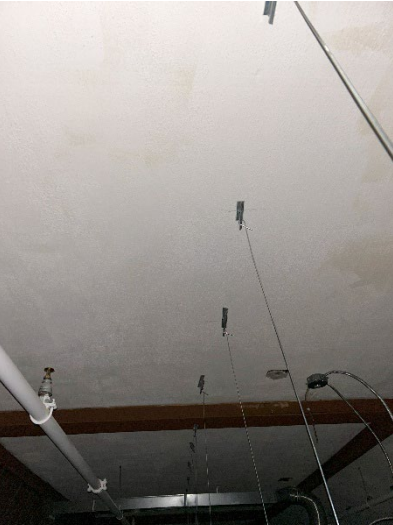
A texture ceiling coat was observed within the ceiling space above the acoustic ceiling tiles in the arena viewing area on the 1st floor. Due to height restrictions, this material was not accessible for sampling. In accordance with industry best practices and regulatory guidelines, the texture coat will be classified as presumed asbestos-containing material (**PACM**) until confirmatory sampling and laboratory analysis can be conducted to determine its asbestos content.

<p>Representative view of the textured ceiling coat observed within the 1st Floor Viewing Area.</p> <p>This material is to be presumed asbestos containing (PACM) until sampling can be conducted.</p>
