October 15, 2021

Town of Deep River
c/o Brad Sweet
Senior Operations Manager
Ontario Clean Water Agency
560 Abbie Lane, PO Box 128
Petawawa, ON
K8H 3R9

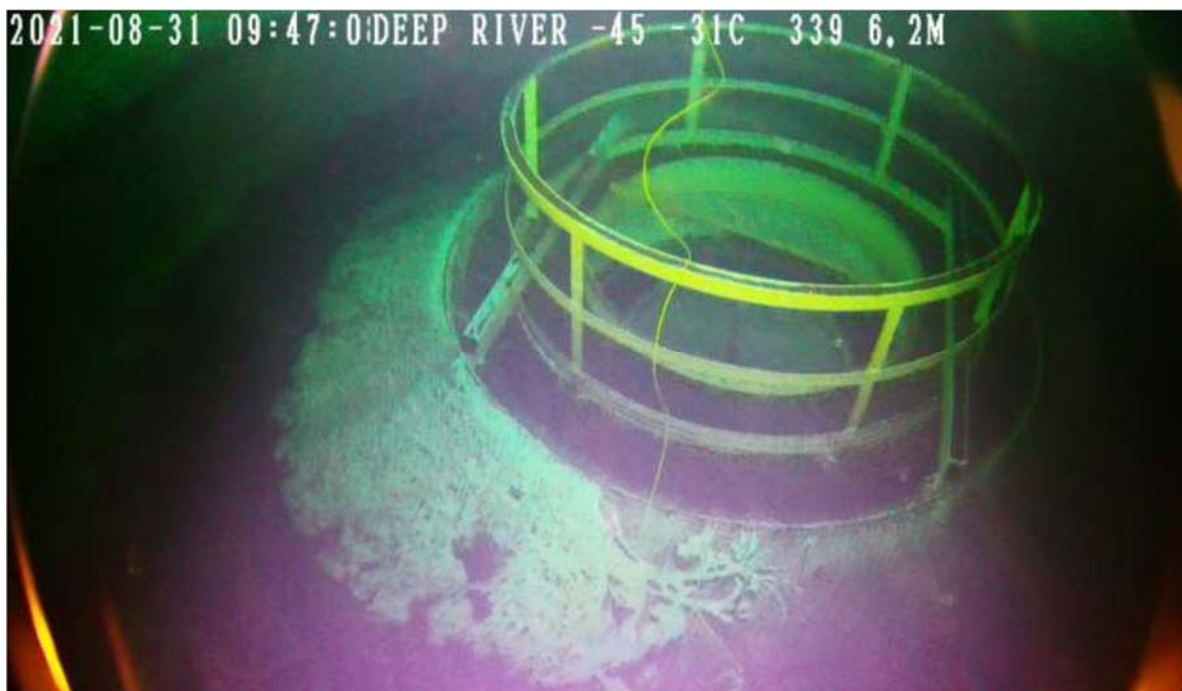
2.5 Safety and Structural Items

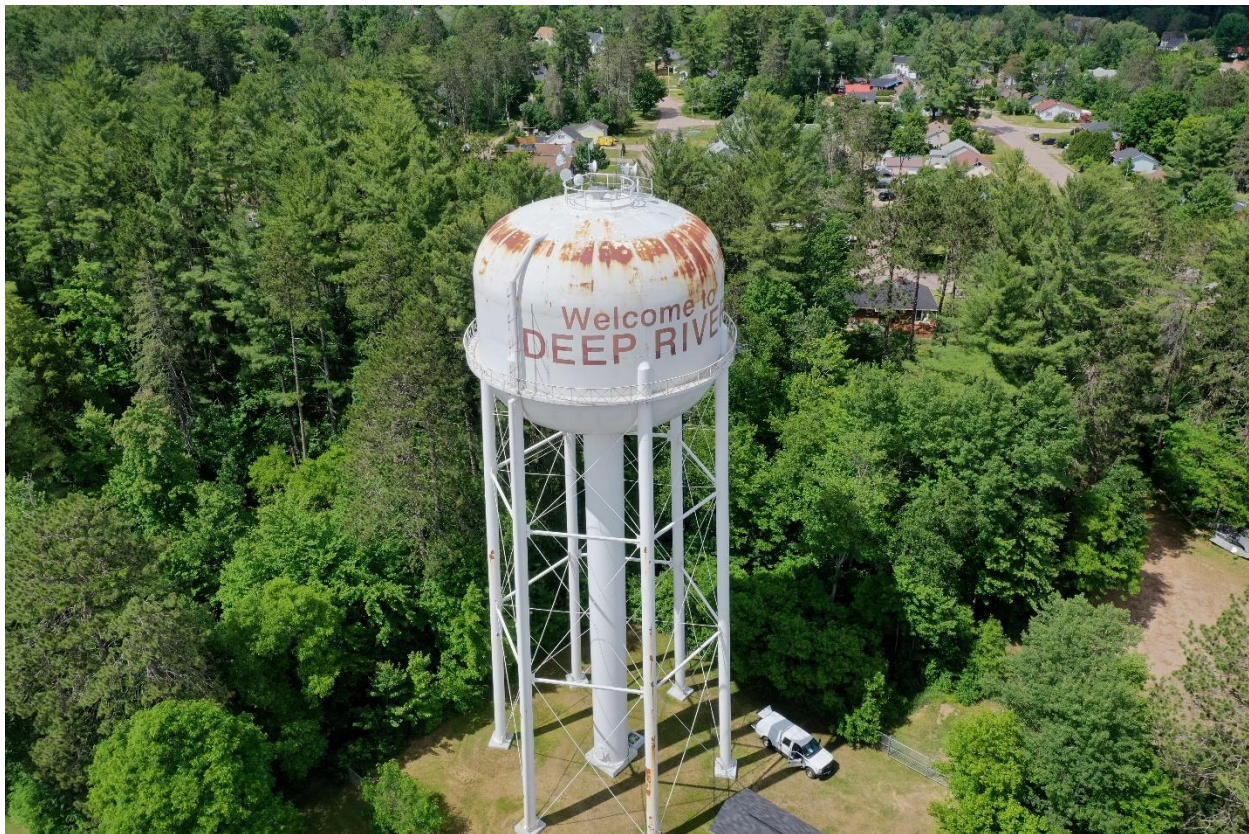
Deep River Water Tower.

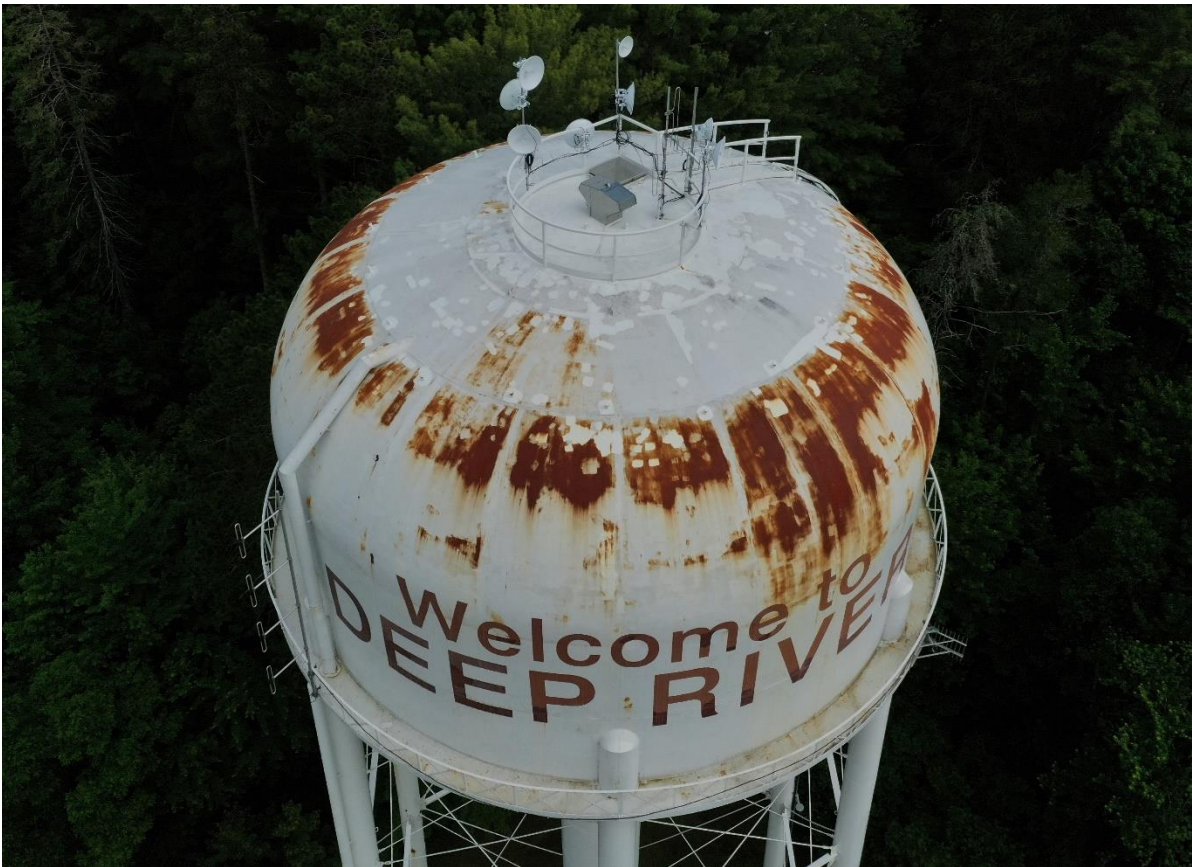
Digital Image #1. – Deep River Water Tower – The exterior coating system on the bowl area of the Deep River water tower were visually inspected and at the time was found to be in poor condition with approximately 30% coatings deterioration occurring.

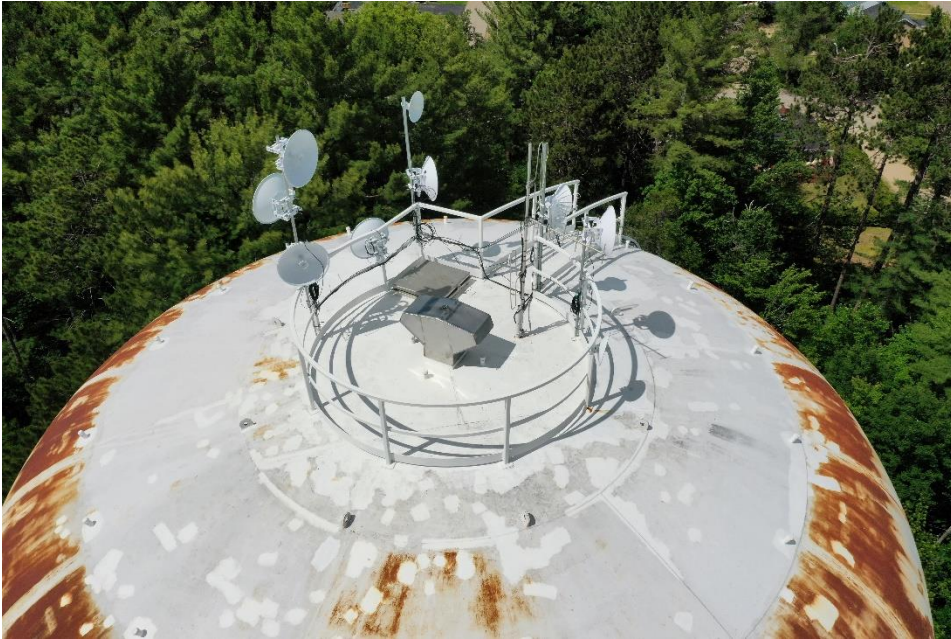
Digital Image #2. – Deep River Water Tower – The exterior coating system on the bowl area of the Deep River water tower were visually inspected and at the time was found to be in poor condition with approximately 30% coatings deterioration occurring.

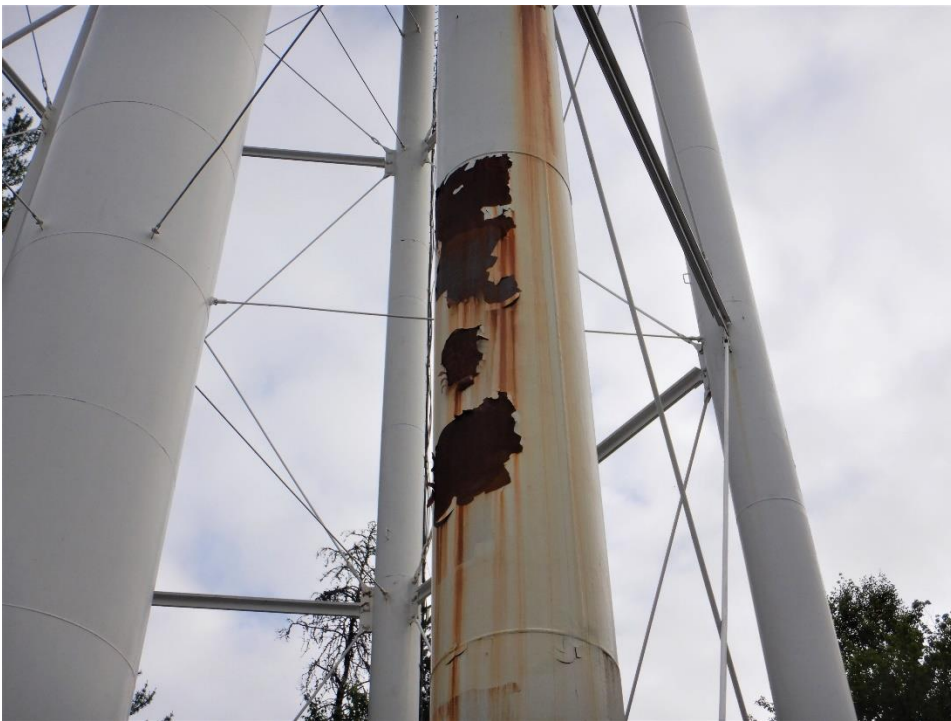
Digital Image #3. – Deep River Water Tower – The exterior coating system on the leg area of the Deep River water tower were visually inspected and at the time was found to be in poor condition with approximately 30% coatings deterioration occurring.

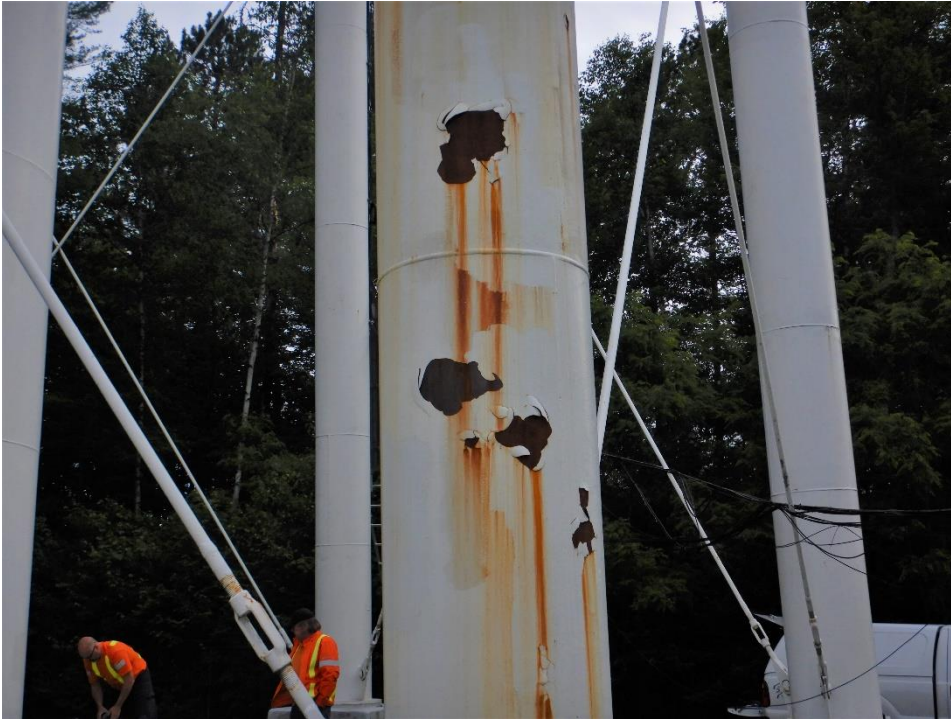
Digital Image #4. – Deep River Water Tower – The exterior coating system on the leg area of the Deep River water tower were visually inspected and at the time was found to be in poor condition with approximately 30% coatings deterioration occurring

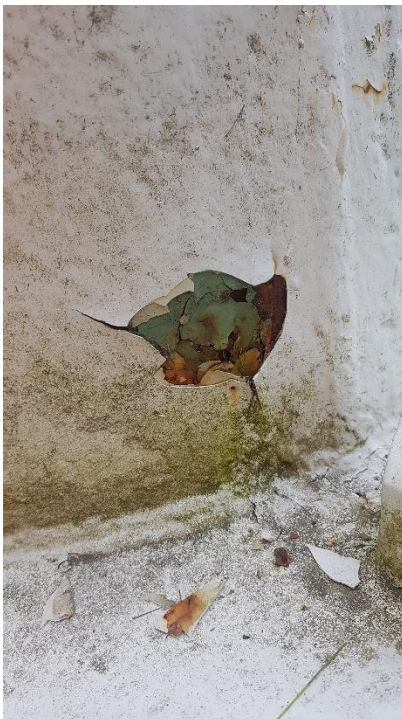
Digital Image #5. – Deep River Water Tower – The exterior coating system on the Deep River water tower appeared to have 6 layers of previous coatings applied.

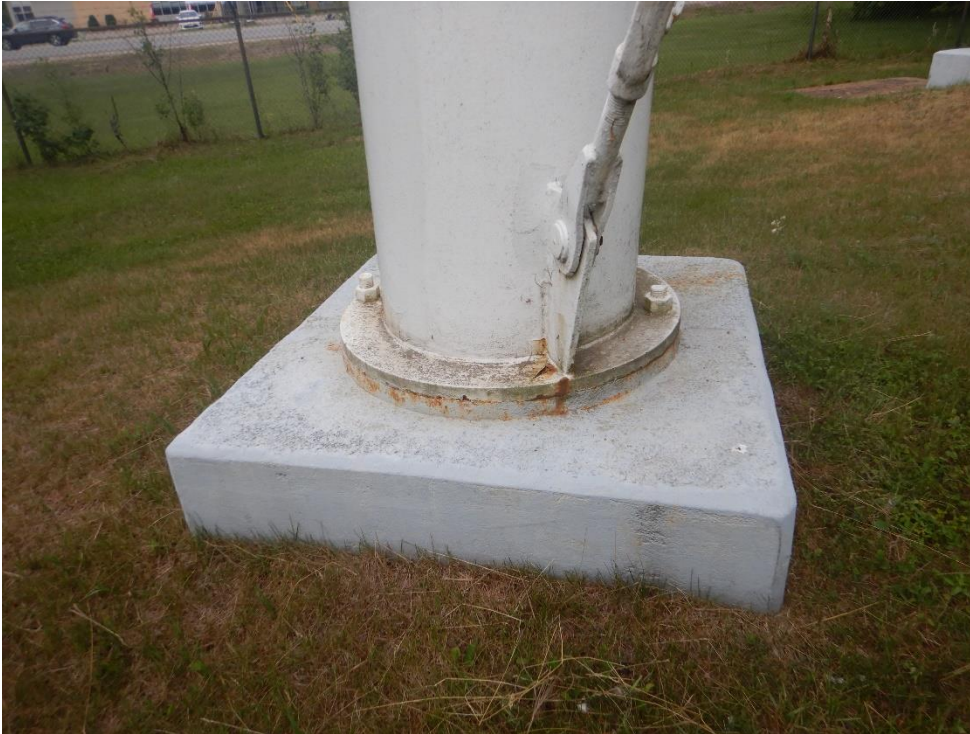
Digital Image #11. – Deep River Water Tower – The tower leg concrete base pads and riser base pad are in good condition with only small amounts of visible weathering and small cracking visible.

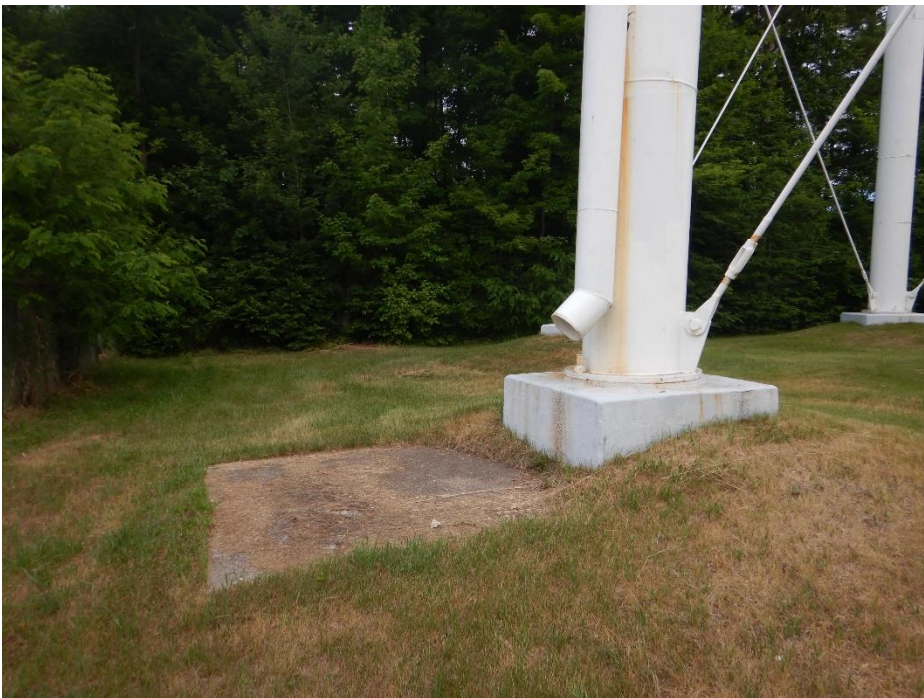
Digital Image #12. – Deep River Water Tower – The tower leg concrete base pad and drainpipe pad are in good condition with only small amounts of visible weathering and small cracking visible. Drainpipe is recommended to be extended to avoid future deterioration of leg concrete base pad.

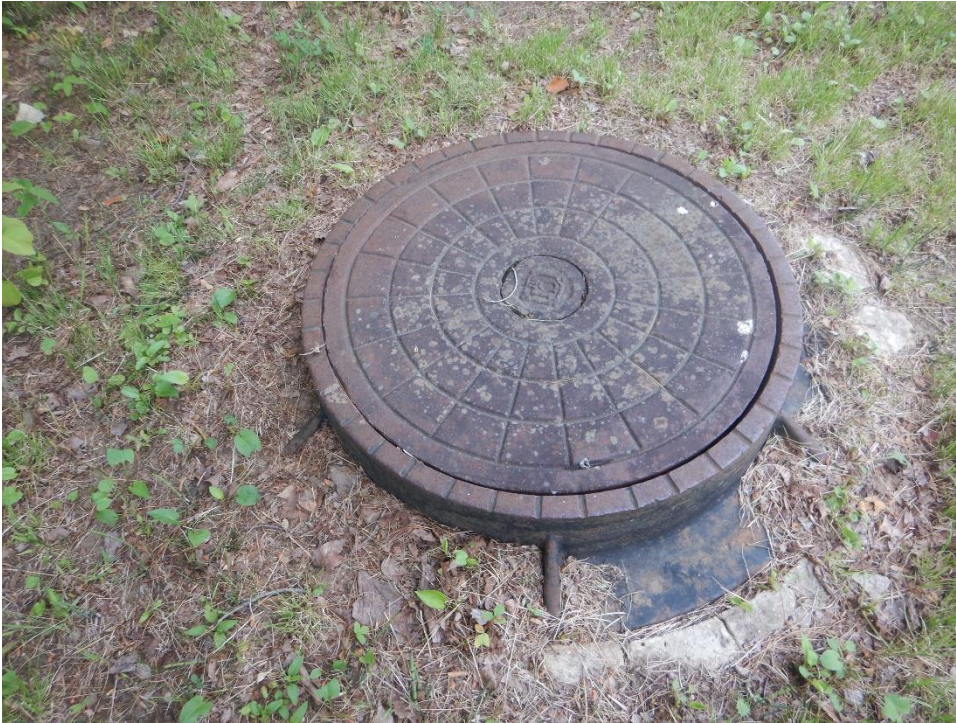
Digital Image #13. – Deep River Water Tower – Two stormwater manways are on the grounds of the tower and are in good condition.

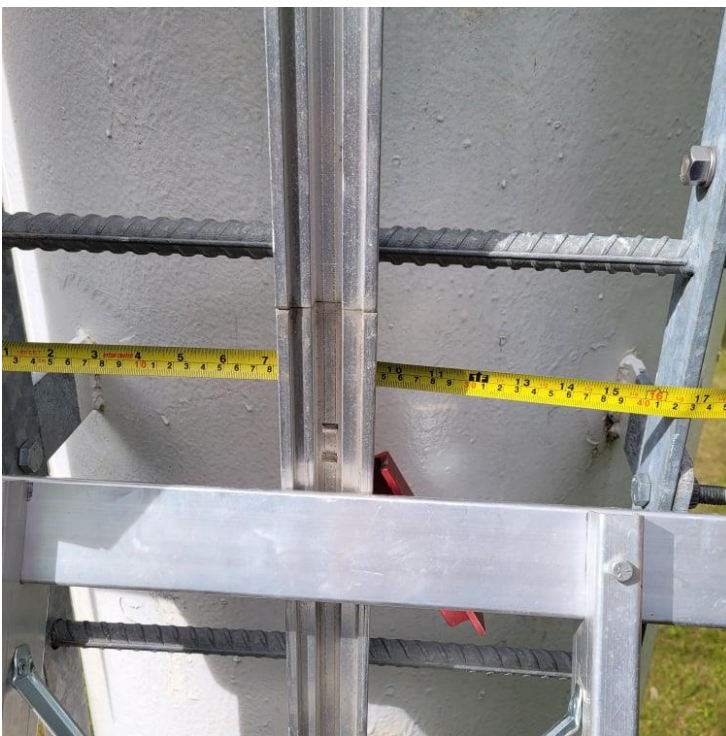
Digital Image #14. – Deep River Water Tower – The ladder to the bowl width of the ladder rungs is 16", which includes the 2 ¼ "aluminum ridge rail, fall arrest system. OH&S specifies a ladder rung spacing total of 23.6".

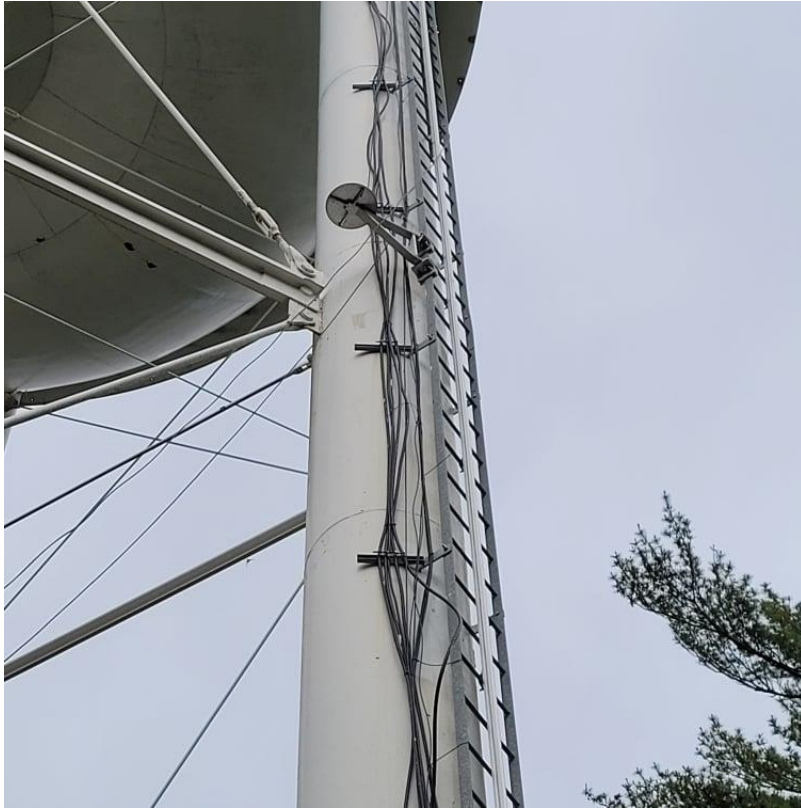
Digital Image #17. – Deep River Water Tower – Internet communication cables are attached to the ground to bowl ladder and obstruct the ladder and the safety rest seats and is recommended to be affixed in a clean manner that will not obstruct access and egress.

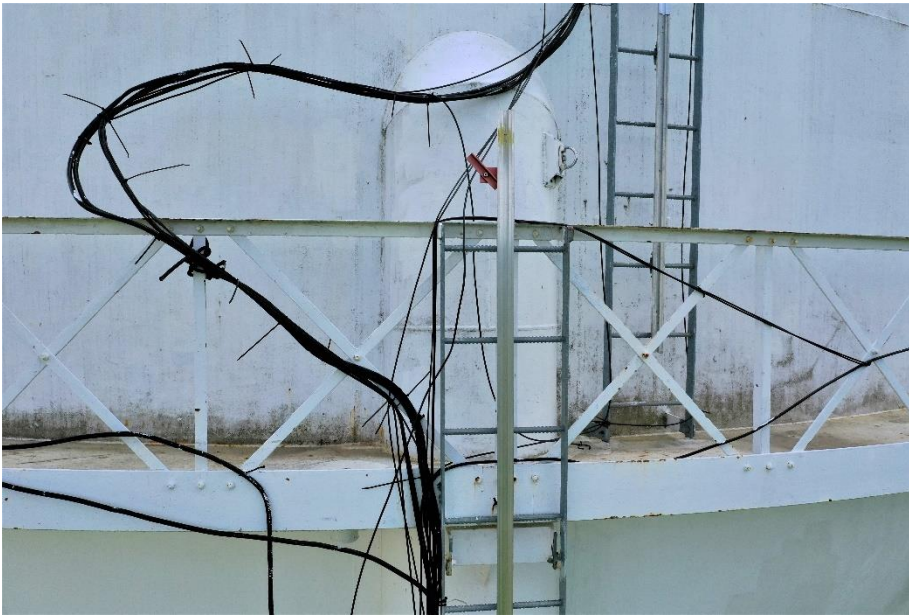
Digital Image #18. – Deep River Water Tower – Internet communication cables hindered the access and egress to the bowl walkway/platform as well as the placement of the walkway handrail, toeboard, extended aluminum ridge rail and fall arrest system.

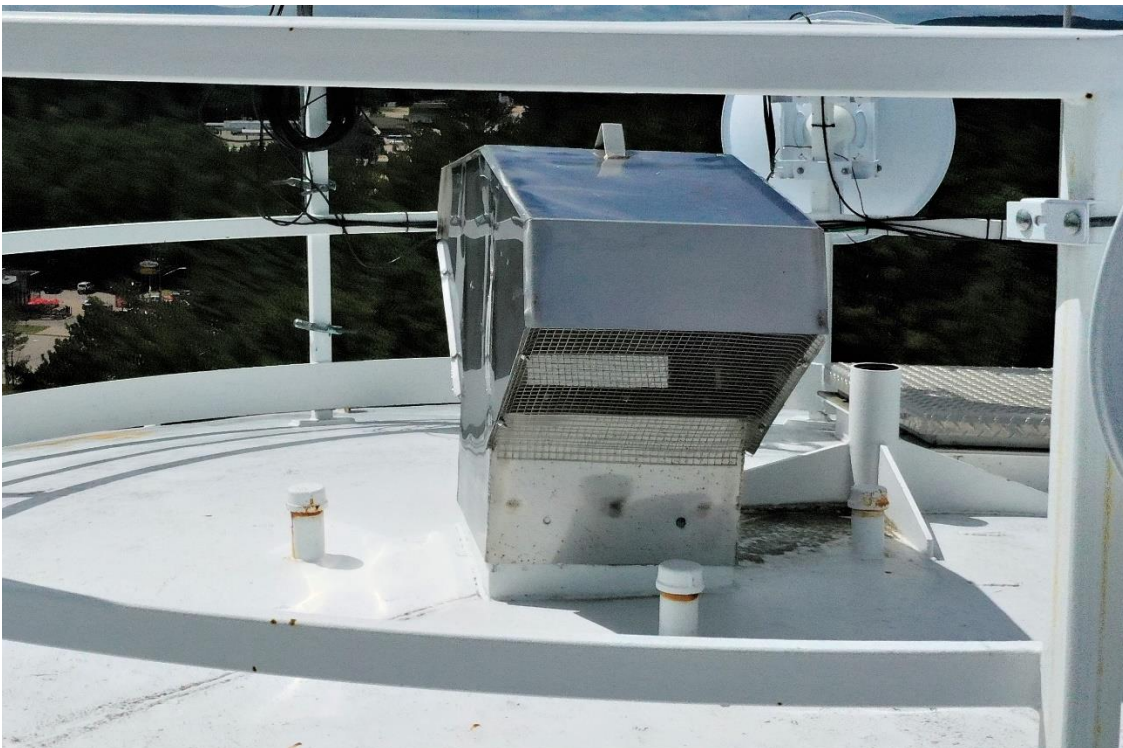
Digital Image #26. – Deep River Water Tower – The bowl roof air vent is in good condition at the time of inspection.

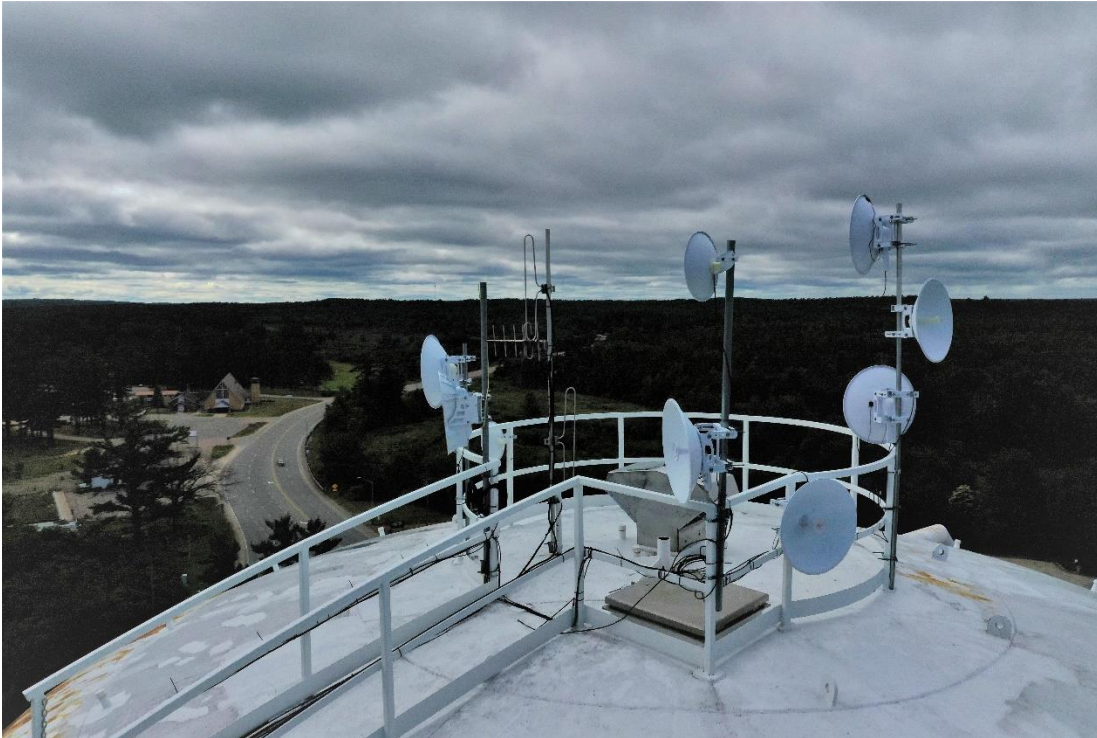
Digital Image #27. – Deep River Water Tower – All communication devices on the tower roof appeared to be securely attached at the time of inspection. No aircraft warning lights are on the water tower roof.

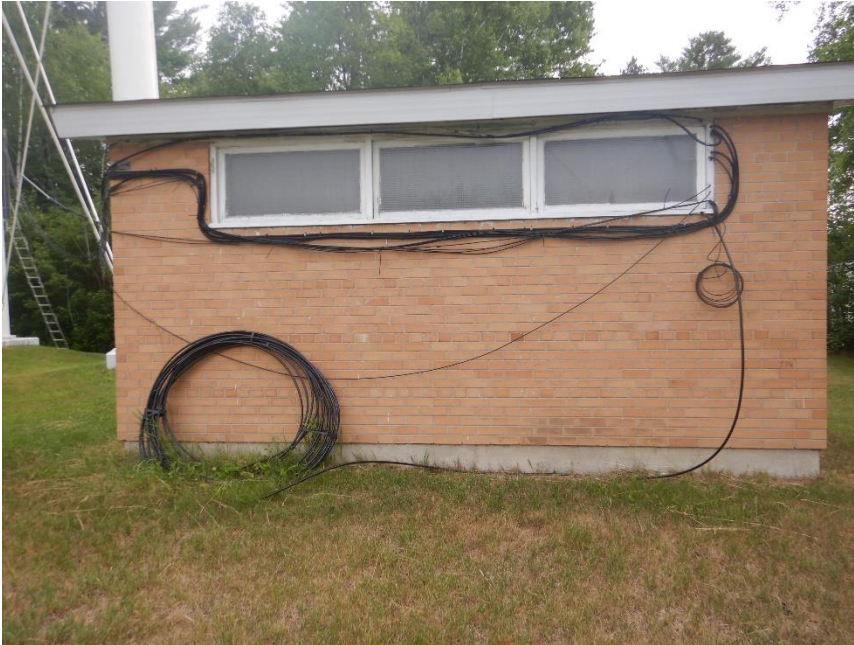
Digital Image #29. – Deep River Water Tower – Communication / Valve chamber house in good condition at the time of inspection. Internet cable management is required.

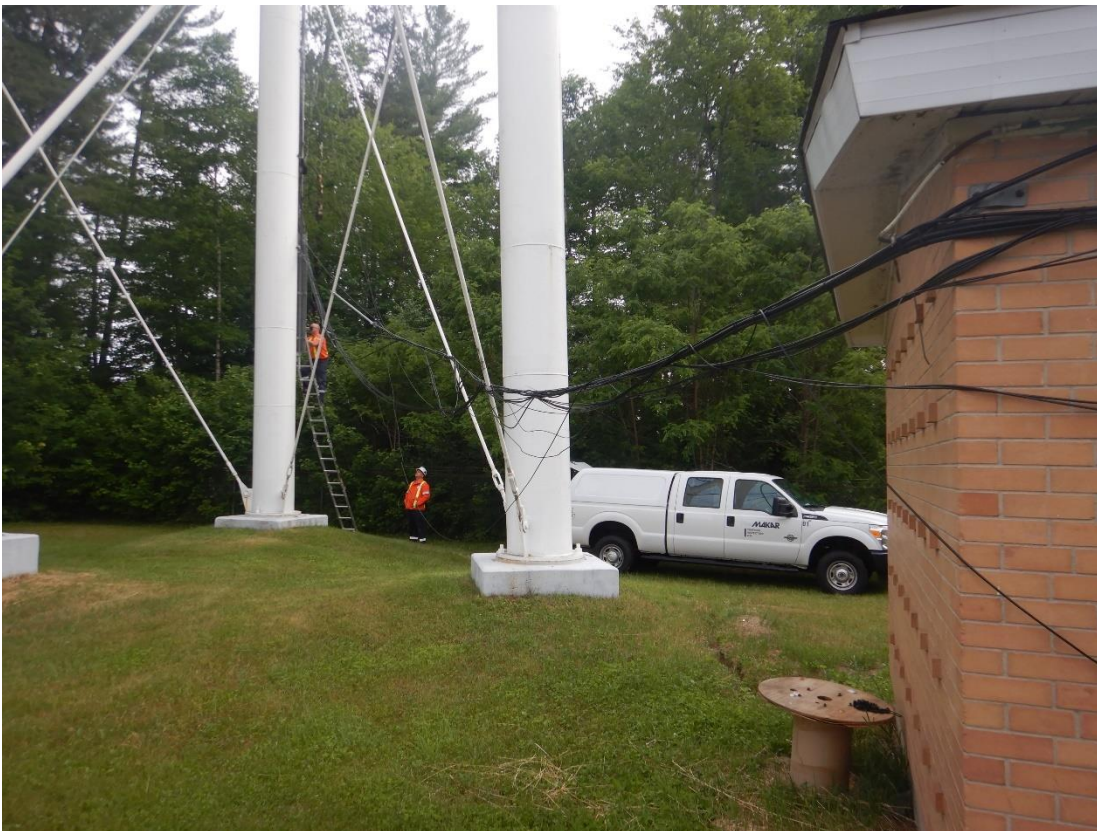
Digital Image #30. – Deep River Water Tower – Communication internet cables require cable management. Cables are tangled and hanging and are obstructing movement around the water tower grounds.

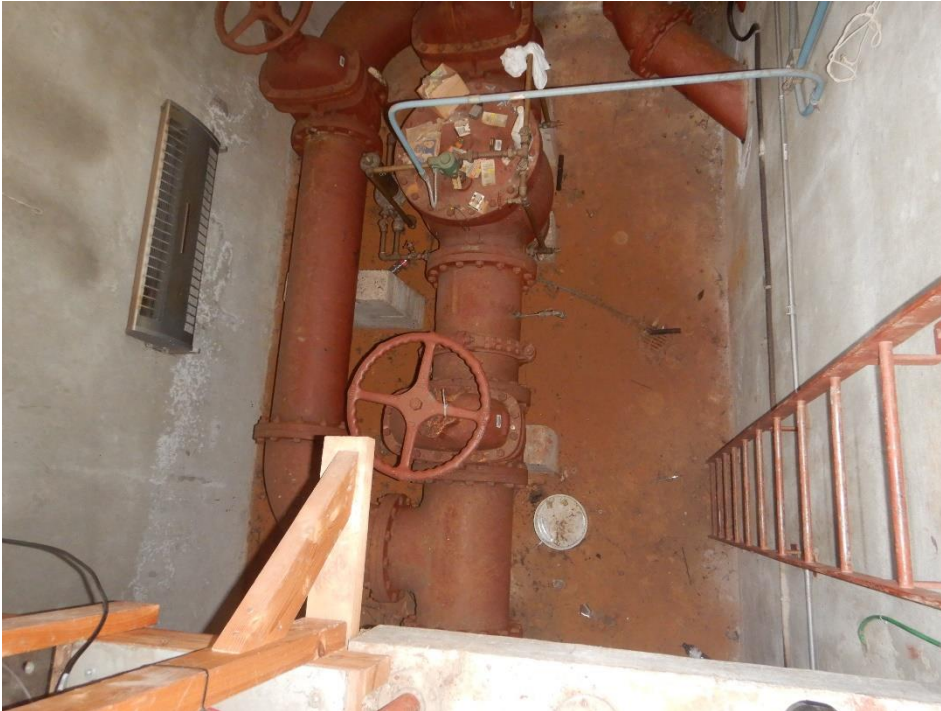
Digital Image #31. – Deep River Water Tower – The valve chamber coating system within the valve chamber has mechanical damage and corrosion occurring.

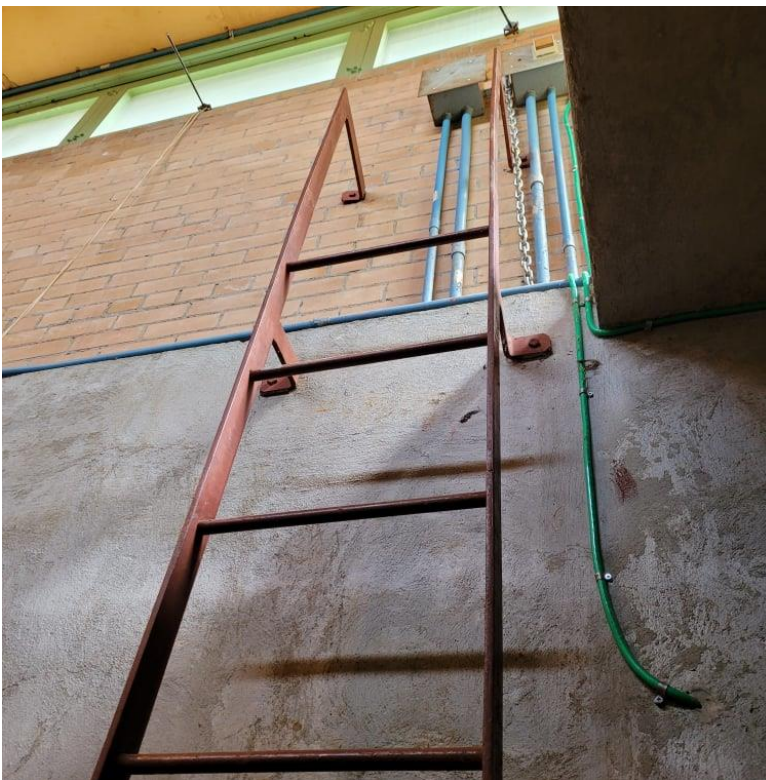
Digital Image #32. – Deep River Water Tower – The valve chamber ladder has no D-Ring at the top of the ladder or fall arrest system in place.

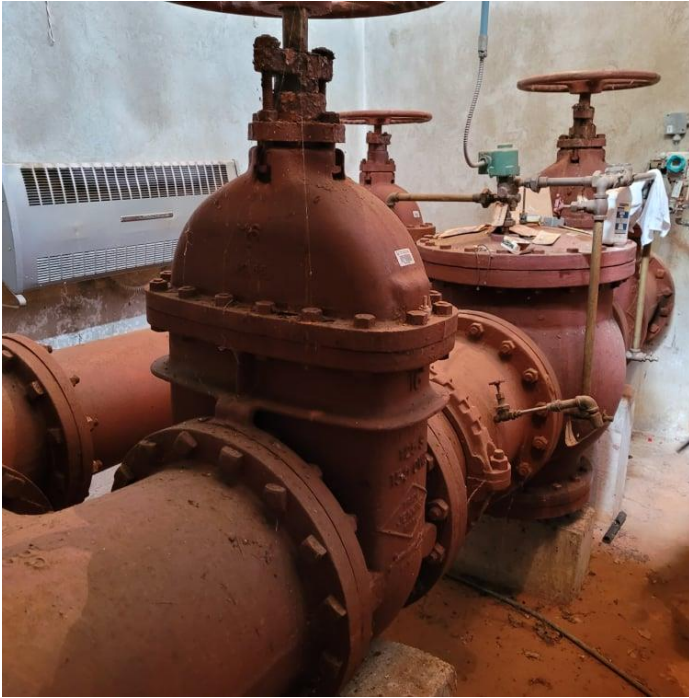
Digital Image #34. – Deep River Water Tower – The valve chamber coating system within the valve chamber has mechanical damage and deep corrosion occurring.

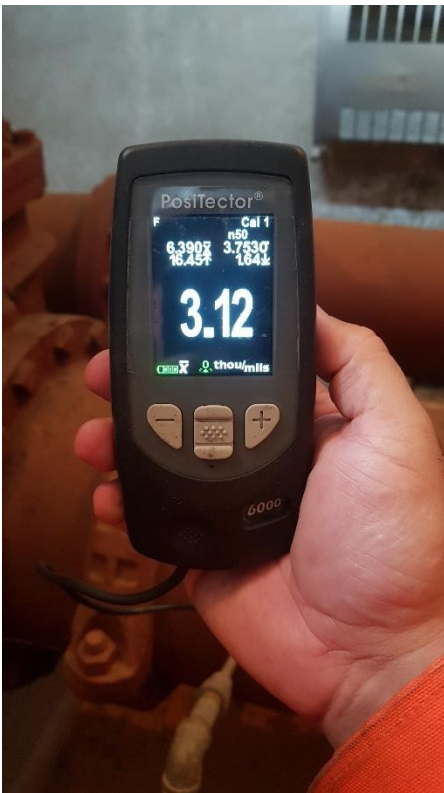
Digital Image #35. – Deep River Water Tower – Fifty (50) dry film thickness readings were taken on the pipeline of the Deep River Water Tower in the valve chamber with PosiTector 6000. The average DFT was 6.39 mils.

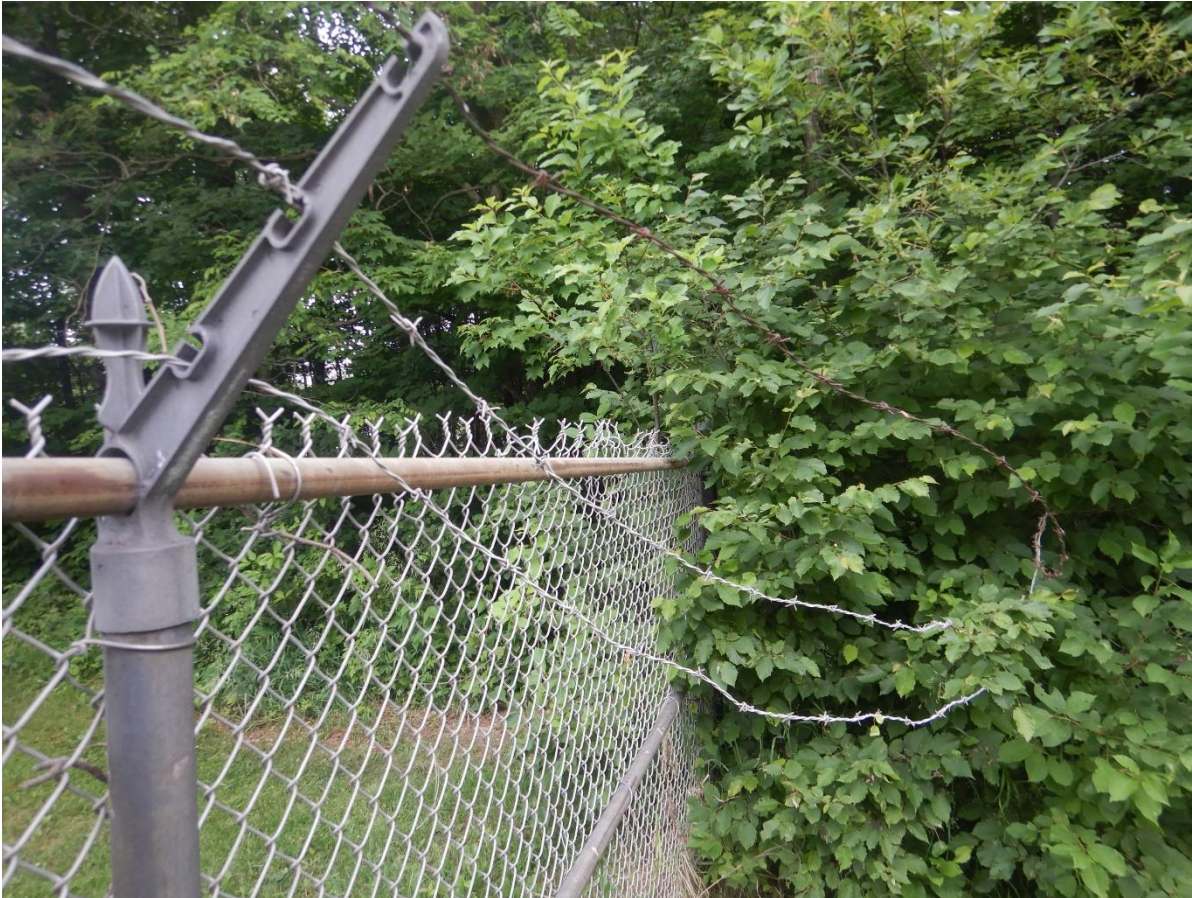
Digital Image #36. – The fence line was inspected and the 3-level barb wire security wire needs to be repaired to maximize security around the water tower.

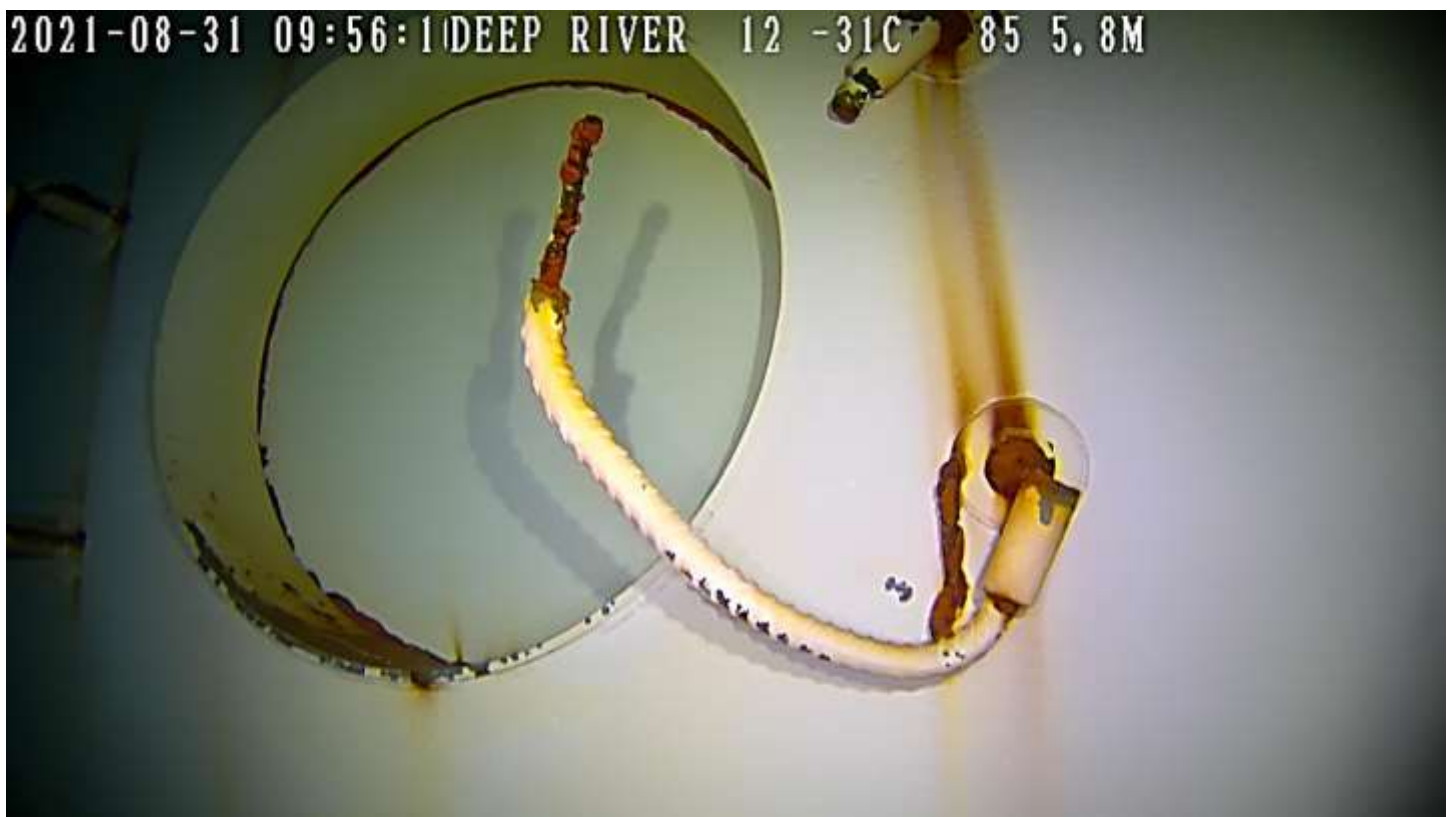
Deep River – Multi-Leg Potable Water Tower – Shell Area – Broken Platform Manway Access Handrailing.

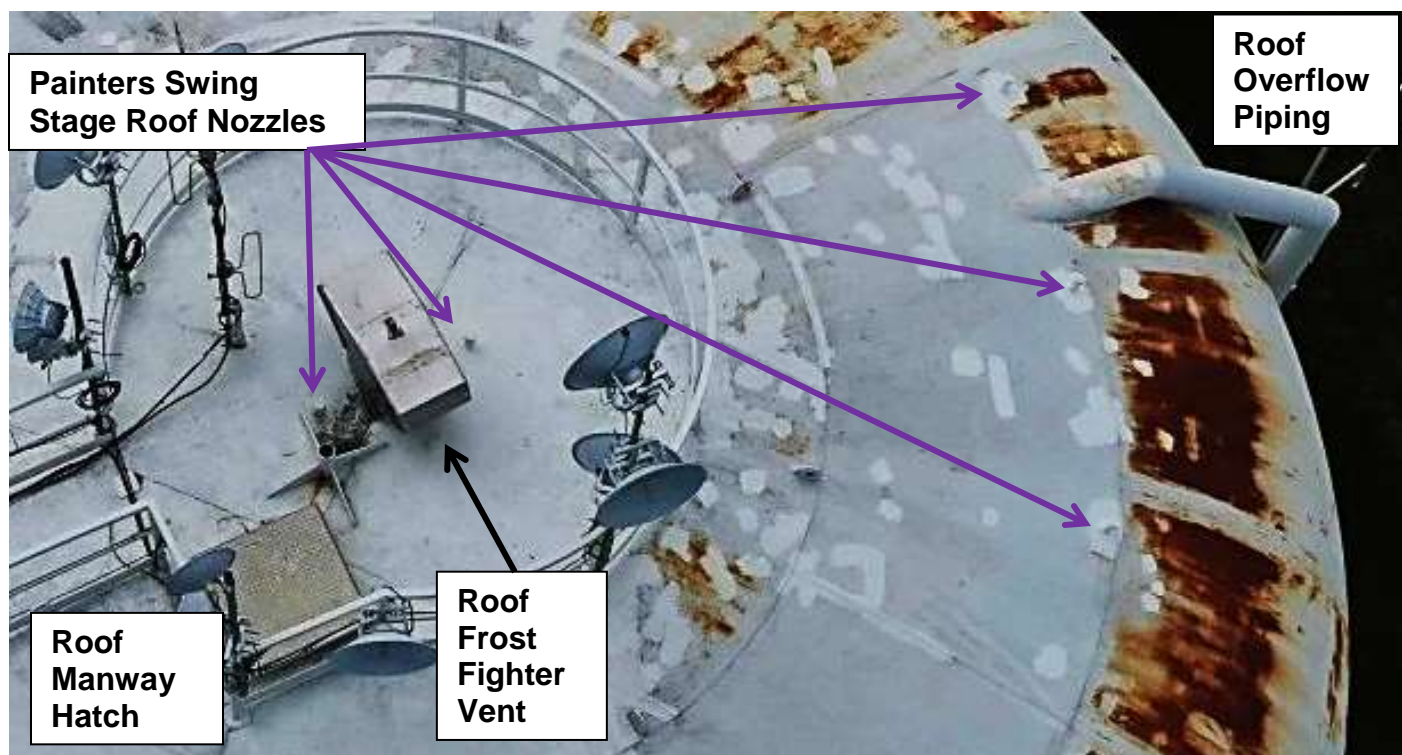
Aerial Drone Image #1 – Deep River Multi-Leg Potable Water Tower – **Exterior** – Roof Area. (Video Image enhanced – brightness & Contrast, to make lining defects standout). Description of exterior roof accessories.

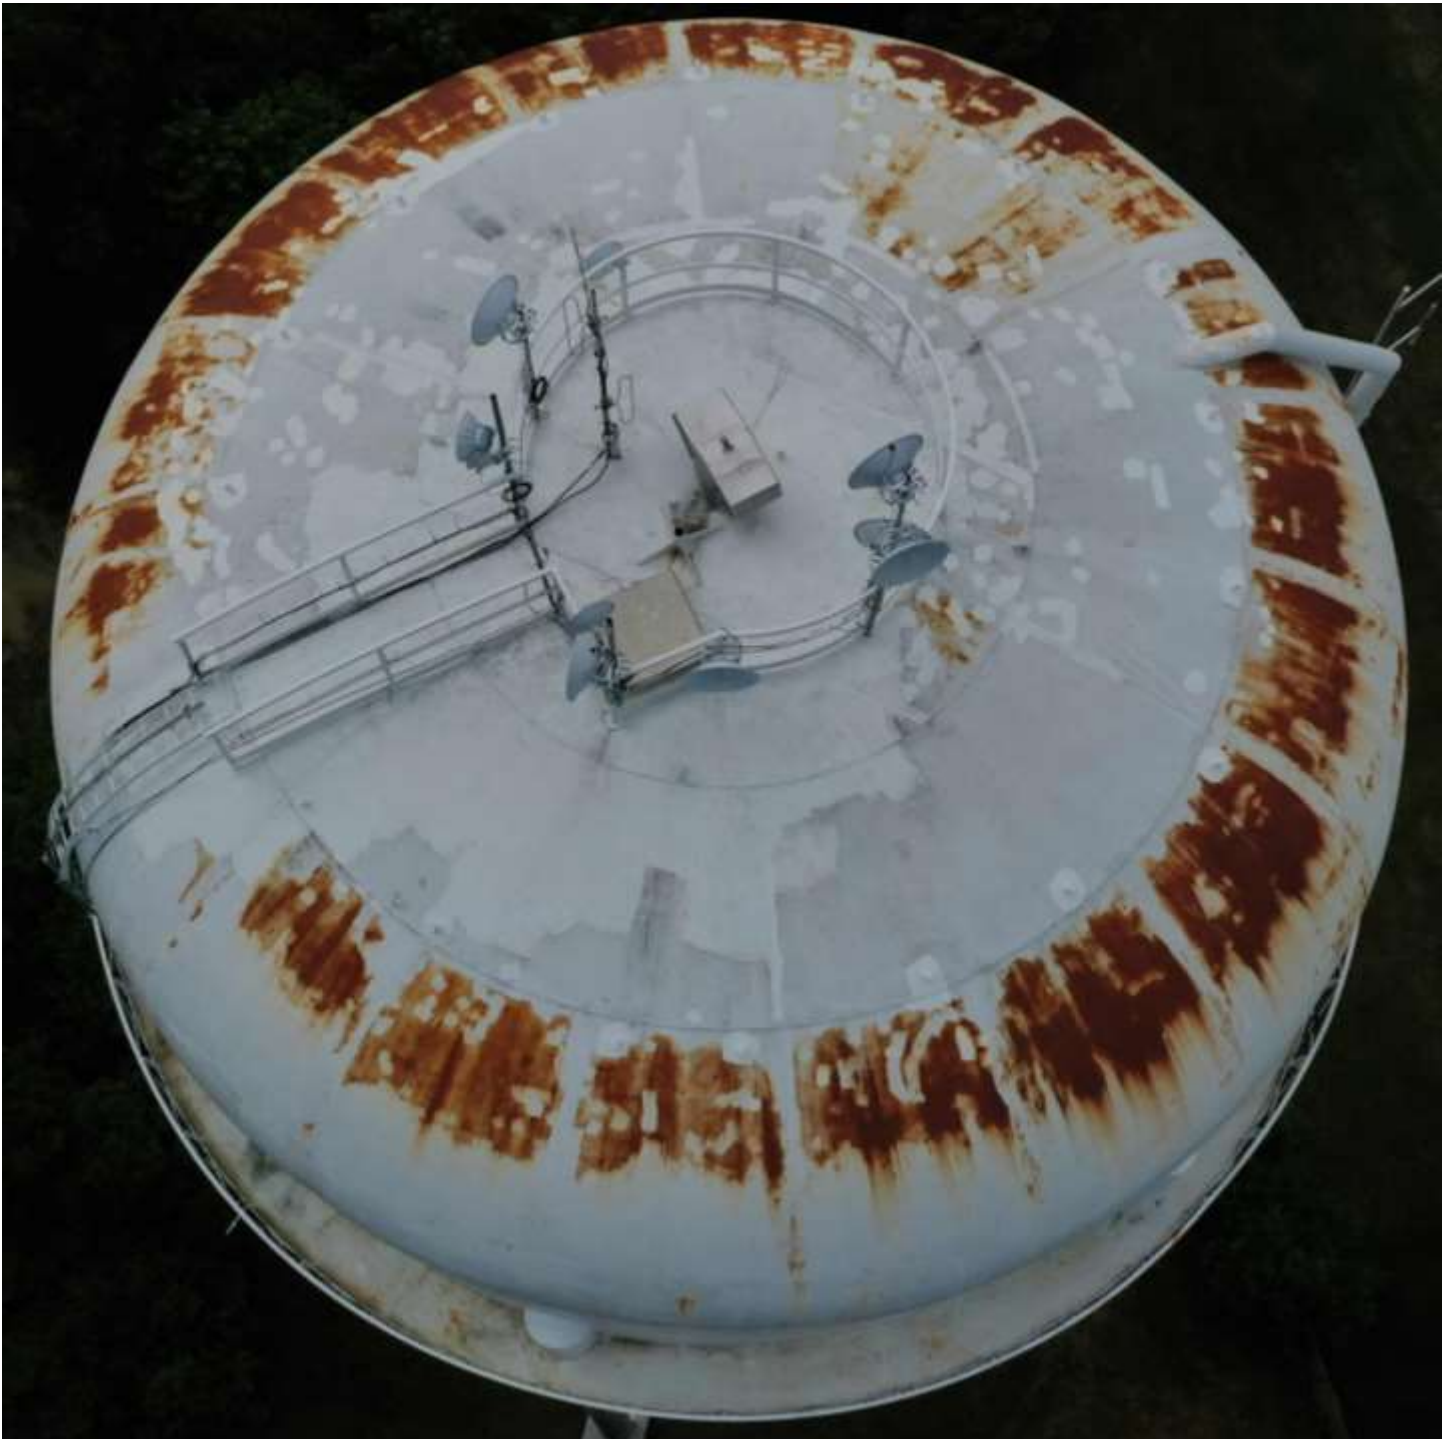
Aerial Drone Image #2 – Deep River Multi-Leg Potable Water Tower – **Exterior** – Roof Area. (Video Image enhanced – brightness & Contrast, to make lining defects stand out). Same as previous image. Discription of exterior roof accessories.

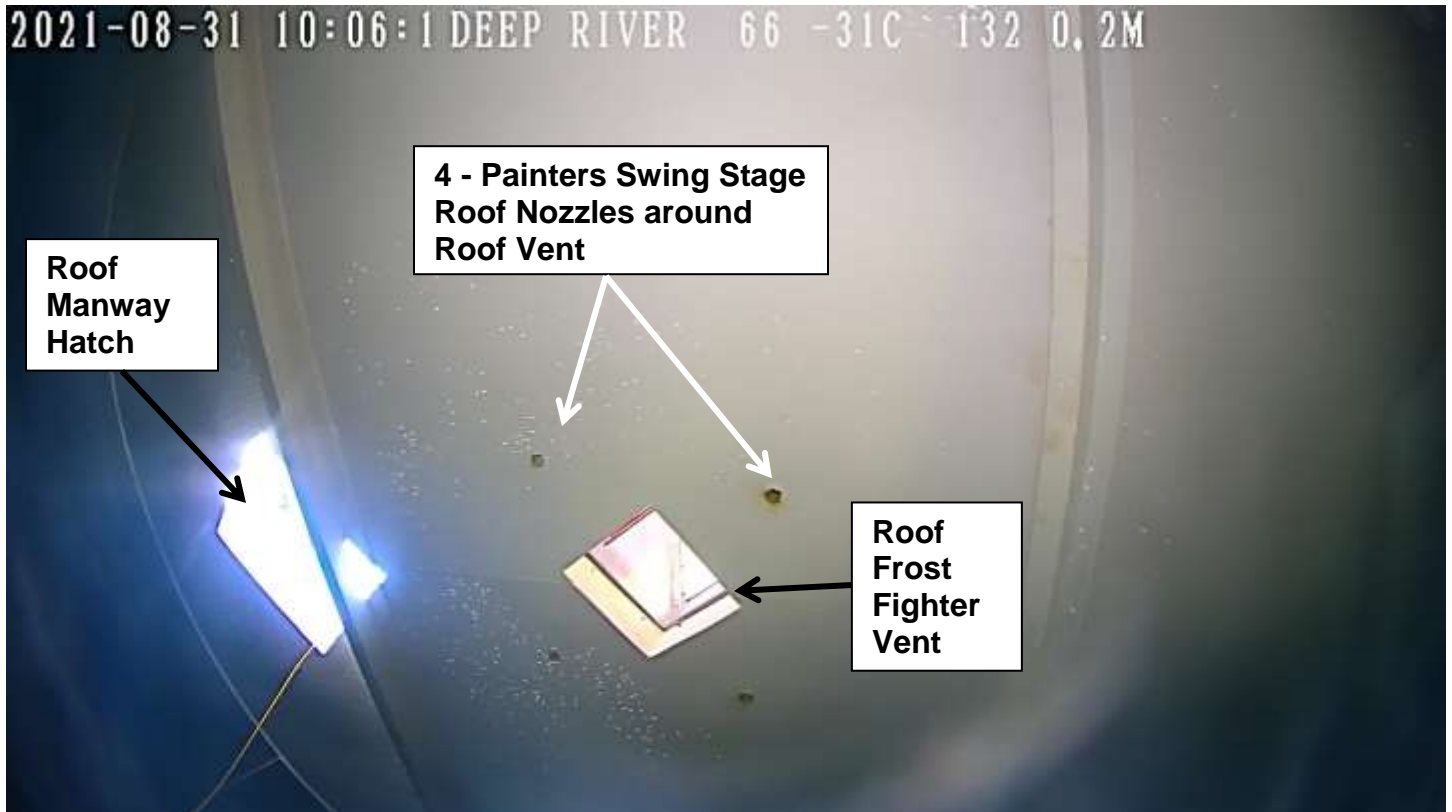
Video Image #1 – Deep River Multi-Leg Potable Water Tower – **Above the Waterline** – Roof Area. (Video Image enhanced – brightness & Contrast, to make lining defects stand out). The lining system on the roof area of the Deep River Tower appears to be in good condition, with a few very minor isolated areas of spot rust streaking apparent at this time.
