October 15, 2021

Town of Deep River
c/o Brad Sweet
Senior Operations Manager
Ontario Clean Water Agency
560 Abbie Lane, PO Box 128
Petawawa, ON
K8H 3R9

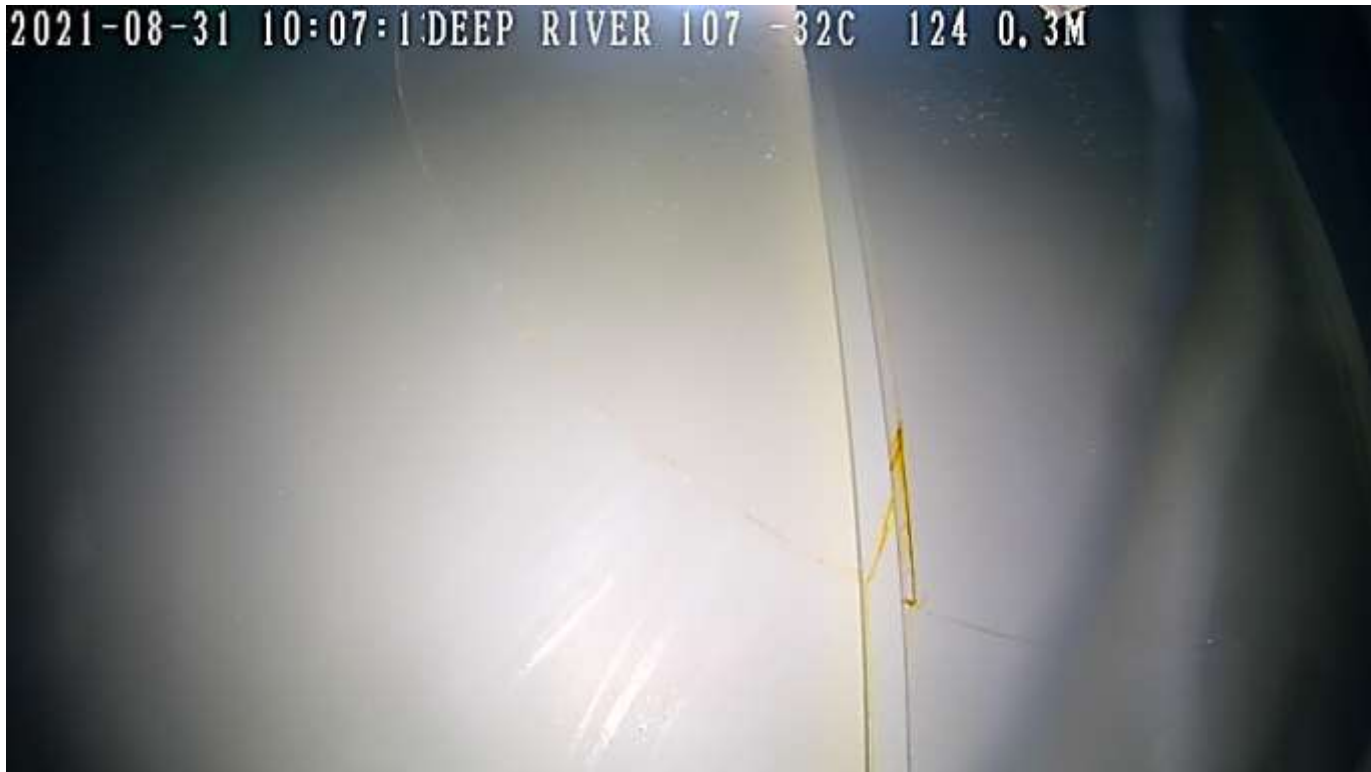
Video Image #2 – Deep River Multi-Leg Potable Water Tower – **Above the Waterline** – Roof Area. (Video Image enhanced – brightness & Contrast, to make lining defects stand out). The lining system on the roof area of the Deep River Tower appears to be in good condition, with a few very minor isolated areas of spot rust streaking apparent at this time.

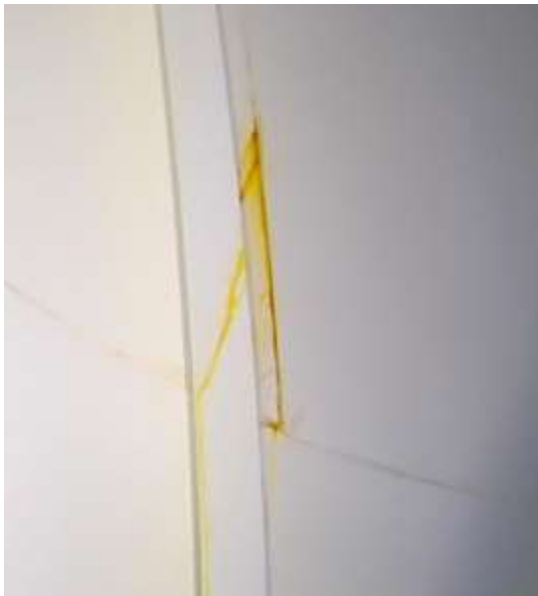
Video Image #3 – Deep River Multi-Leg Potable Water Tower – **Above the Waterline** – Roof Area. (Video Image enhanced – brightness & Contrast, to make lining defects stand out). Same as previous video image, image cropped and zoomed in. Rust present on roof weld seam.

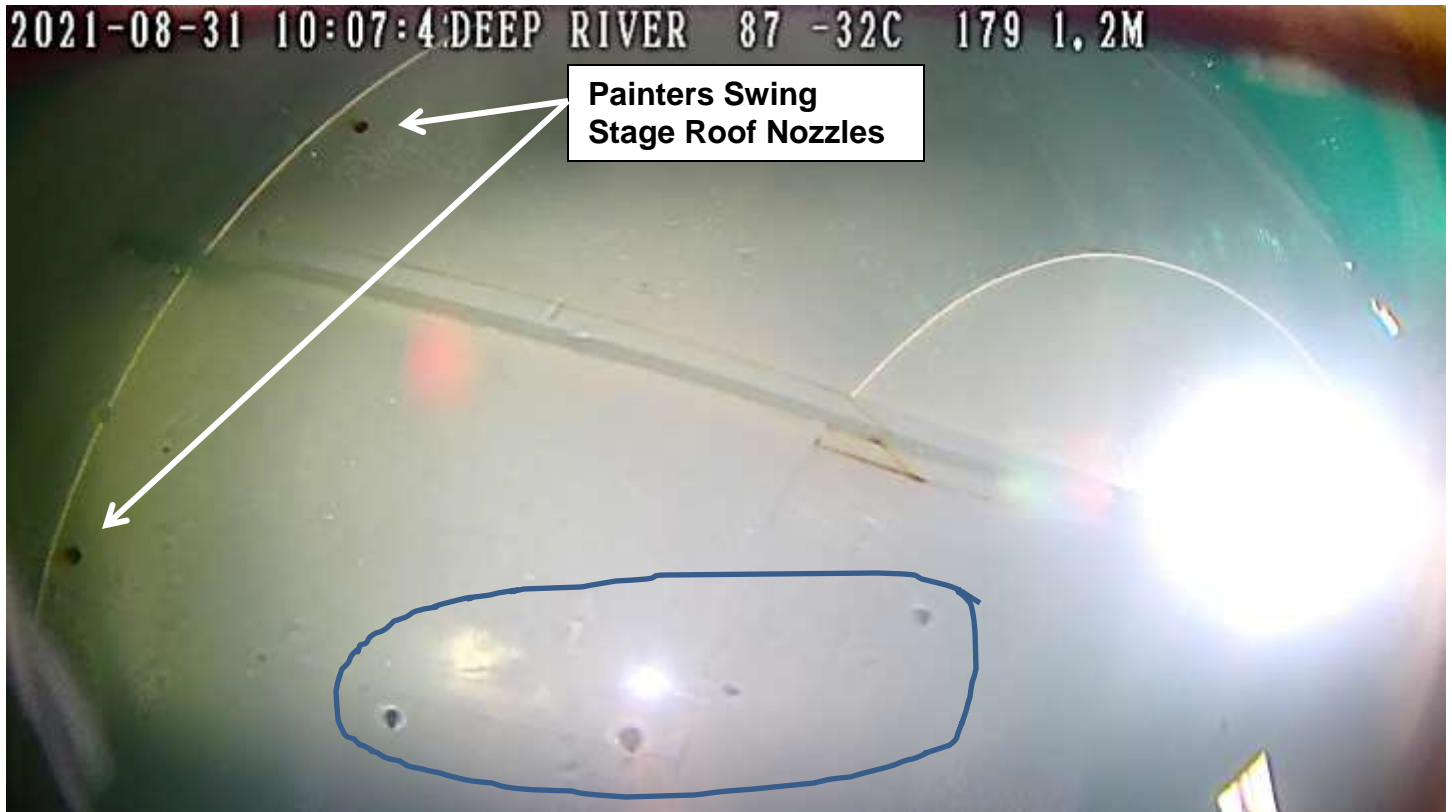
Video Image #4 – Deep River Multi-Leg Potable Water Tower – **Above the water level** – Roof Area. (Video Image enhanced – brightness & Contrast, to make lining defects stand out). A few very minor isolated areas of spot rust streaking appeared at this time. (“This writer is not assured of the dark spots on the roof area, which has been circled in blue, they may be painters swing stage nozzles or exposed primer/mid coats since there is no rust streaking from the dark spots”).

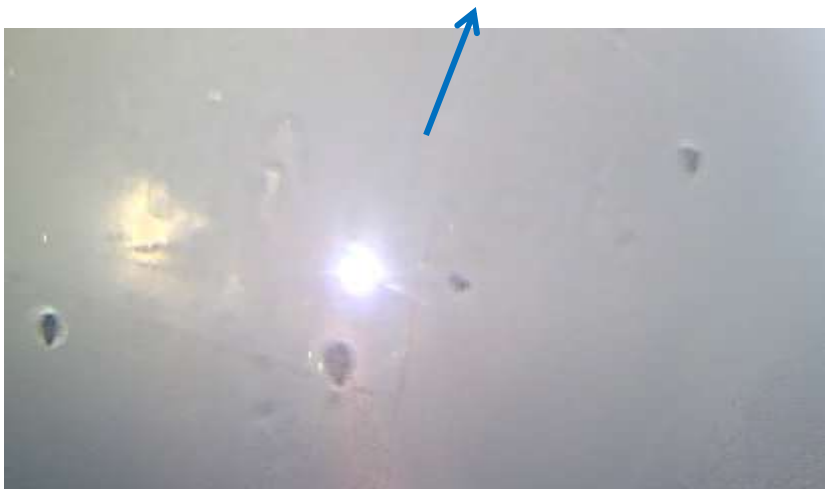
Video Image #5 – Deep River Multi-Leg Potable Water Tower – **Above the water level** – Roof Area. (Video Image enhanced – brightness & Contrast, to make lining defects stand out). Same as previous video image, image cropped and zoomed in. (“This writer is not assured of the dark spots on the roof area, which has been circled in blue, they may be painters swing stage nozzles or exposed primer/mid coats, since there is no rust streaking from the dark spots”).

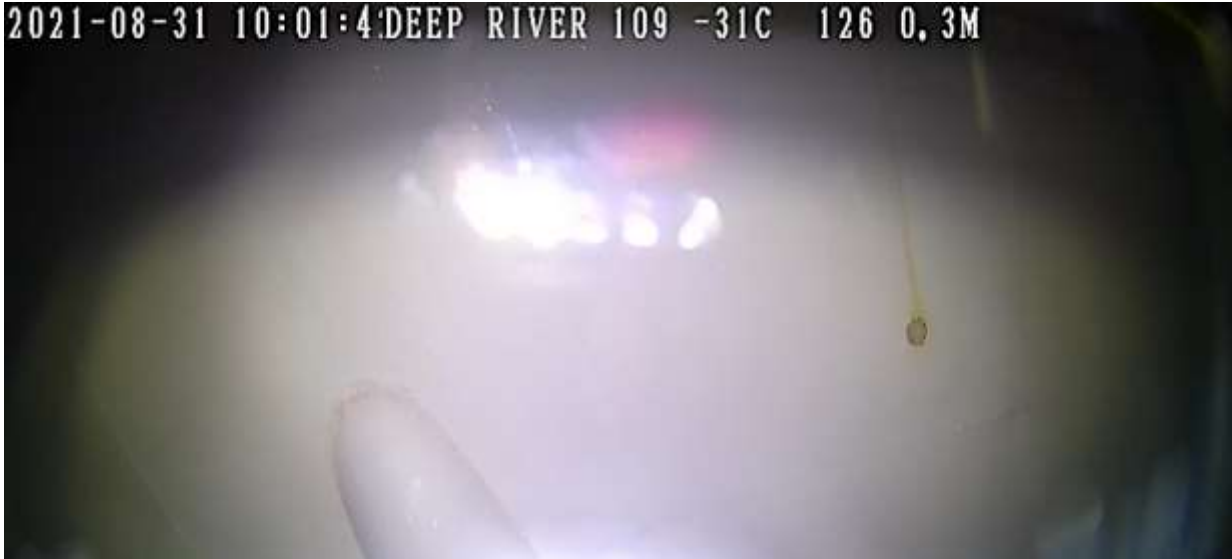
Video Image #6 – Deep River Multi-Leg Potable Water Tower – **Above the water level** – Roof Area.
(Video Image enhanced – brightness & Contrast, to make lining defects stand out). Roof overflow pipe and painters nozzle.

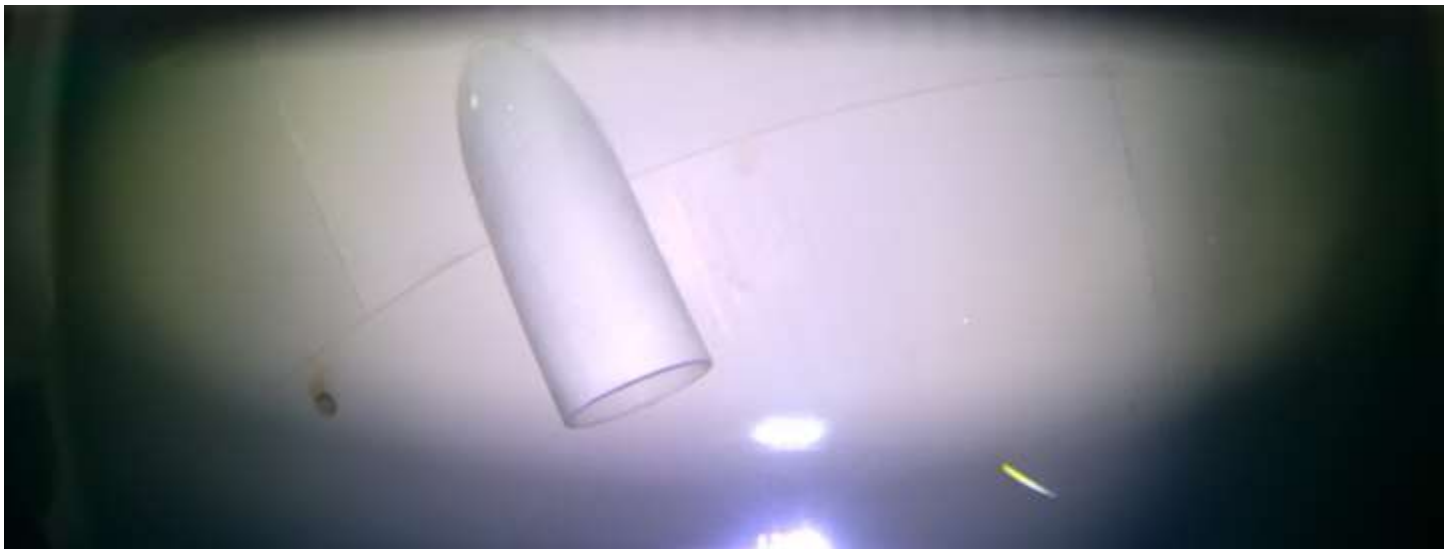
Video Image #7 – Deep River Multi-Leg Potable Water Tower – **Above the Waterline** – Roof Area.
(Video Image enhanced – brightness & Contrast, to make lining defects stand out). Same as previous video image, image cropped and zoomed in.

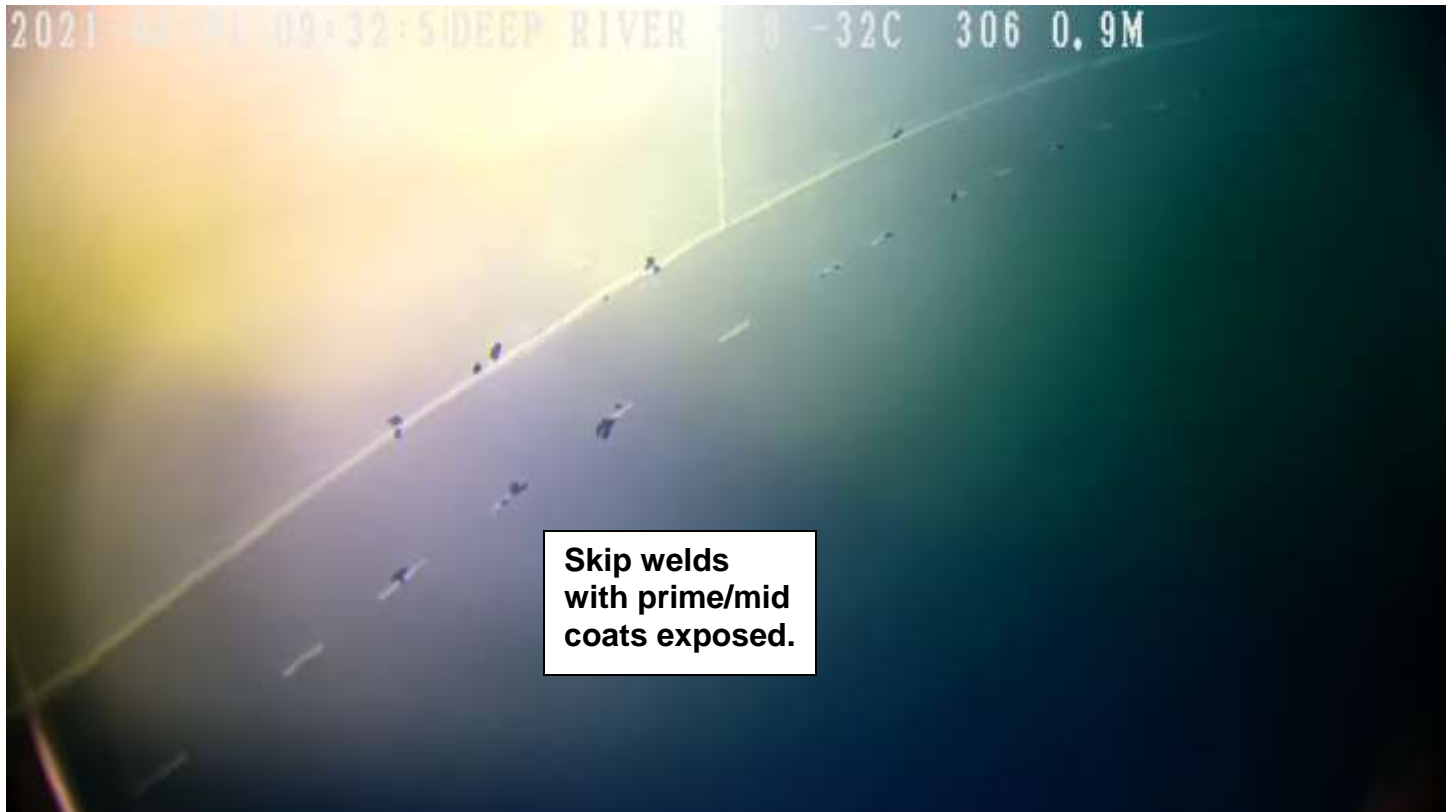
Video Image #8 – Deep River Multi-Leg Potable Water Tower – **Below the Waterline** – Upper Shell Area. (Video Image enhanced – brightness & Contrast, to make lining defects stand out). Generally the lining system on the shell area of the Deep River Tower appears to be in good condition. This upper area of the shell, appears to be in the “water fluctuation zone”, where water and particularly ice builds up in the winter months and fluctuates up and down within the tower and rubs the lining system where there is protrusions. In this area, the protrusions are the weld seam and skip welds. Please note there is no rust streaking, just exposed primer and/or mid coats.

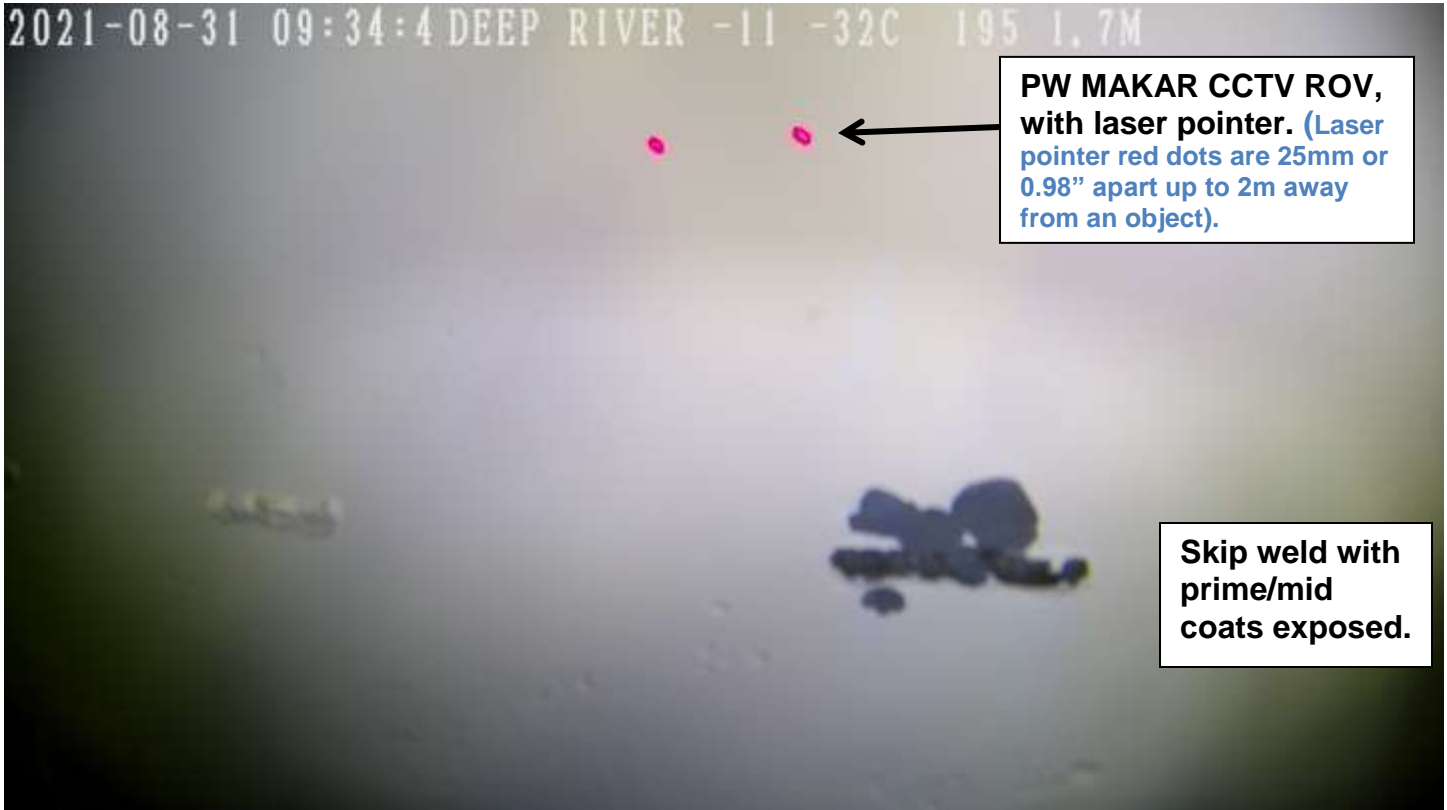
Video Image #9 – Deep River Multi-Leg Potable Water Tower – **Below the Waterline** – Upper Shell Area. (Video Image enhanced – brightness & Contrast, to make lining defects stand out). Generally, the lining system on the shell area of the Deep River Tower appears to be in good condition. This upper area of the shell, appears to be in the “water fluctuation zone”, where water and particularly ice builds up in the winter months and fluctuates up and down within the tower and rubs the lining system where there is protrusions. In this area, the protrusions are the weld seam and skip welds. Please note there is no rust streaking, just exposed primer and/or mid coats.

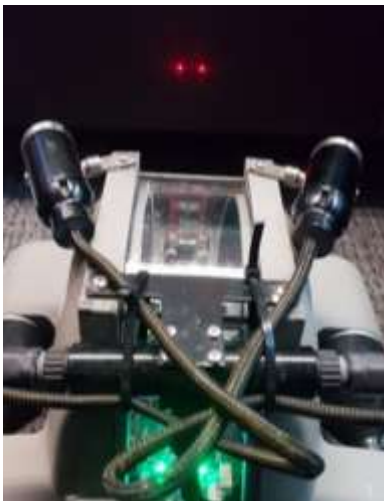
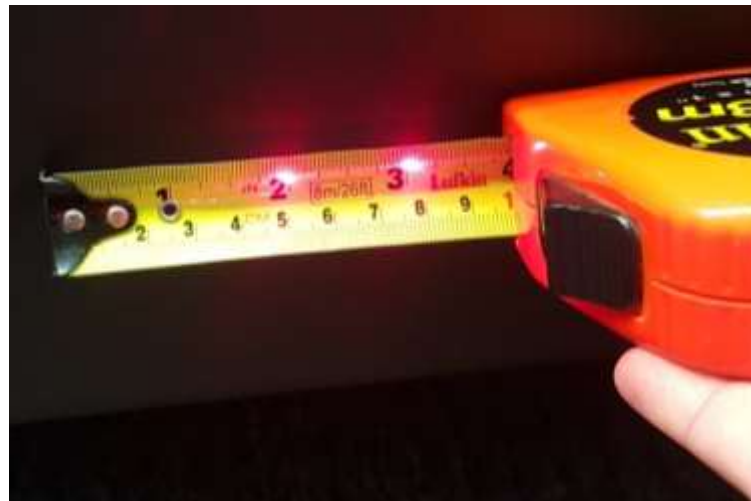
Photo #1 & 2. PW MAKAR COATINGS INSPECTION LTD., Upgraded underwater ROV, CCTV system with laser pointer. Laser pointer red dots are 25mm or 0.98” apart up to 2m away from an object.

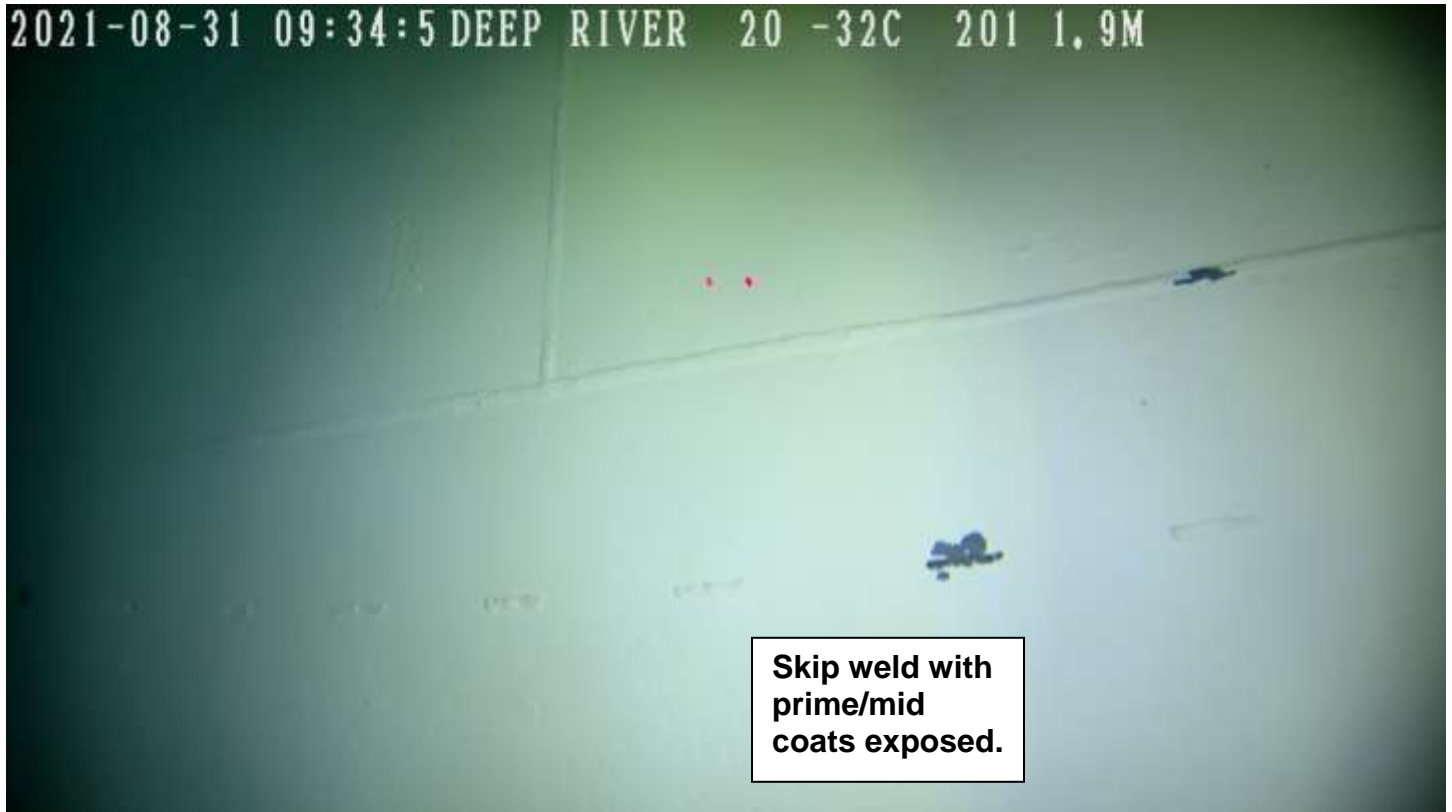
**Skip weld with
prime/mid
coats exposed.**

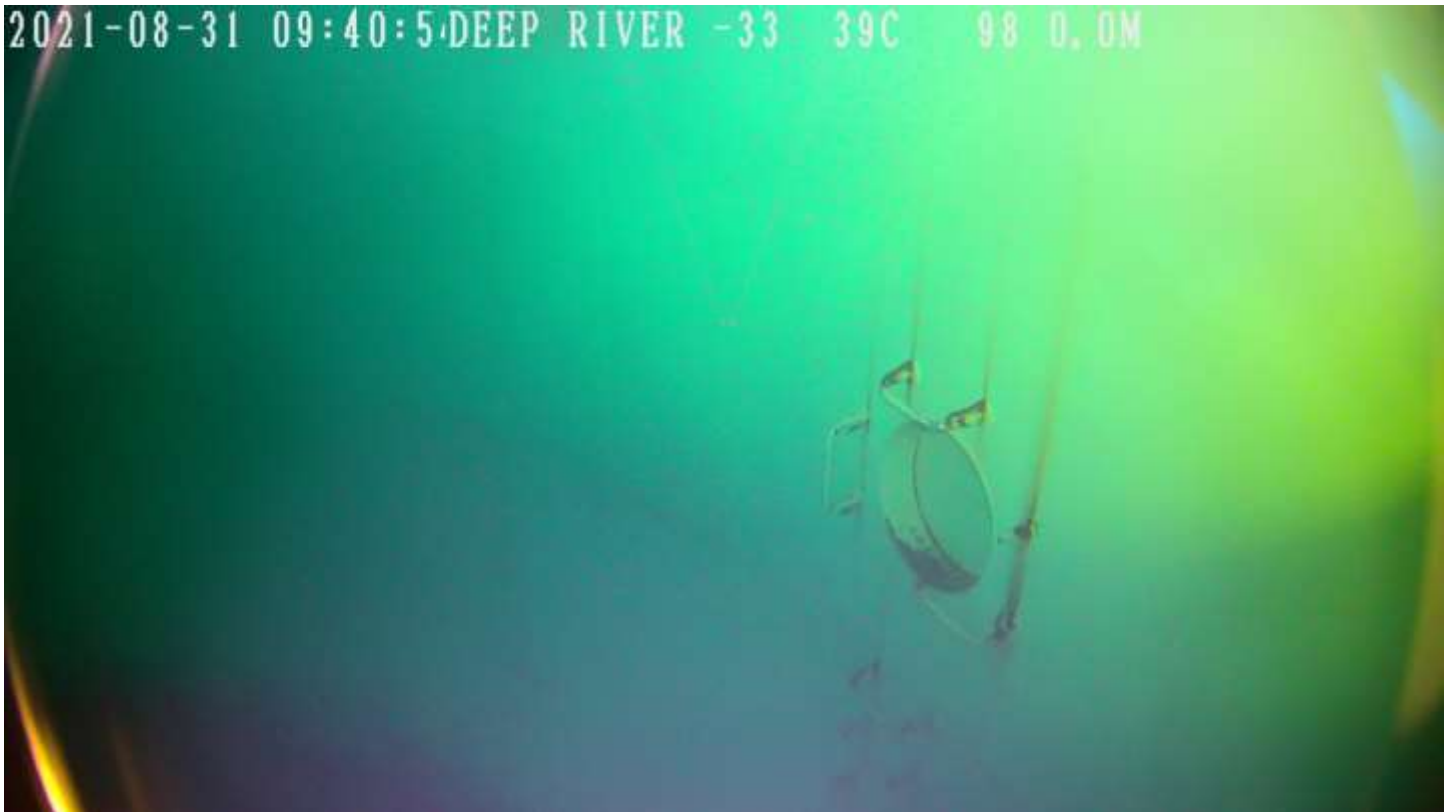
Video Image #11 – Deep River Multi-Leg Potable Water Tower – **Below the Waterline** – Lower Shell Area. (Video Image enhanced – brightness & Contrast, to make lining defects stand out). Generally, the lining system on the shell area of the Deep River Tower appears to be in good condition. Rust streaking from Platform Manway access handrailings. Note, on the right side of the manway, the handrailing is broken.

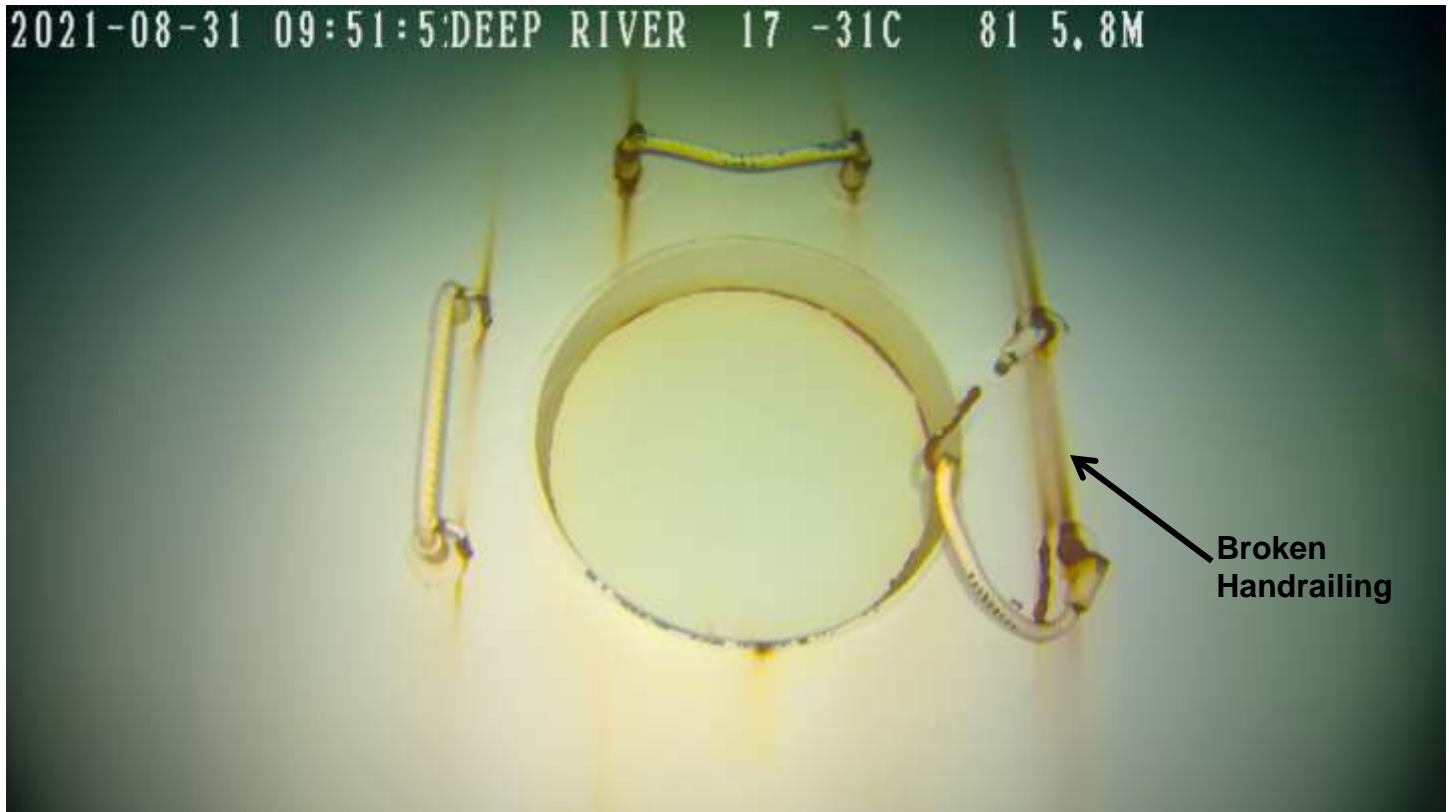
Video Image #12 – Deep River Multi-Leg Potable Water Tower – **Below the Waterline** – Lower Shell Area. (Video Image enhanced – brightness & Contrast, to make lining defects stand out). Generally, the lining system on the shell area of the Deep River Tower appears to be in good condition. Rust streaking from platform manway access handrailings. Note, on the right side of the manway, the handrailing is broken.

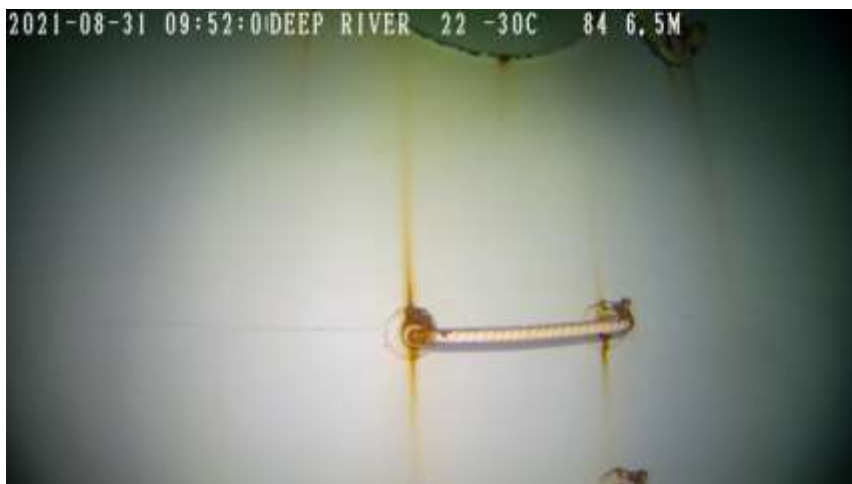
Video Image #13 – Deep River Multi-Leg Potable Water Tower – **Below the Waterline** – Lower Shell Area. (Video Image enhanced – brightness & Contrast, to make lining defects stand out). Generally, the lining system on the shell area of the Deep River Tower appears to be in good condition. Platform mainway ladder rungs appear to be intact at this time.

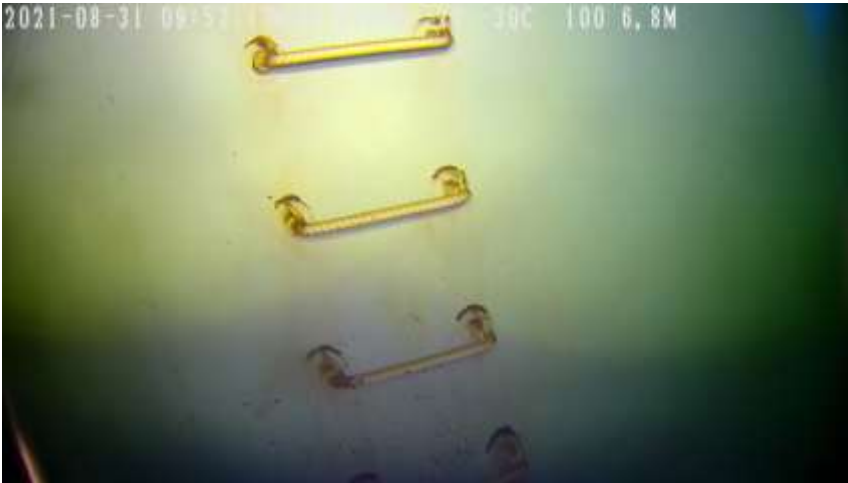
Video Image #14 – Deep River Multi-Leg Potable Water Tower – **Below the Waterline** – Lower Shell Area. (Video Image enhanced – brightness & Contrast, to make lining defects stand out). Generally, the lining system on the shell area of the Deep River Tower appears to be in good condition. Same as previous video image. Platform mainway ladder rungs appear to be intact at this time.

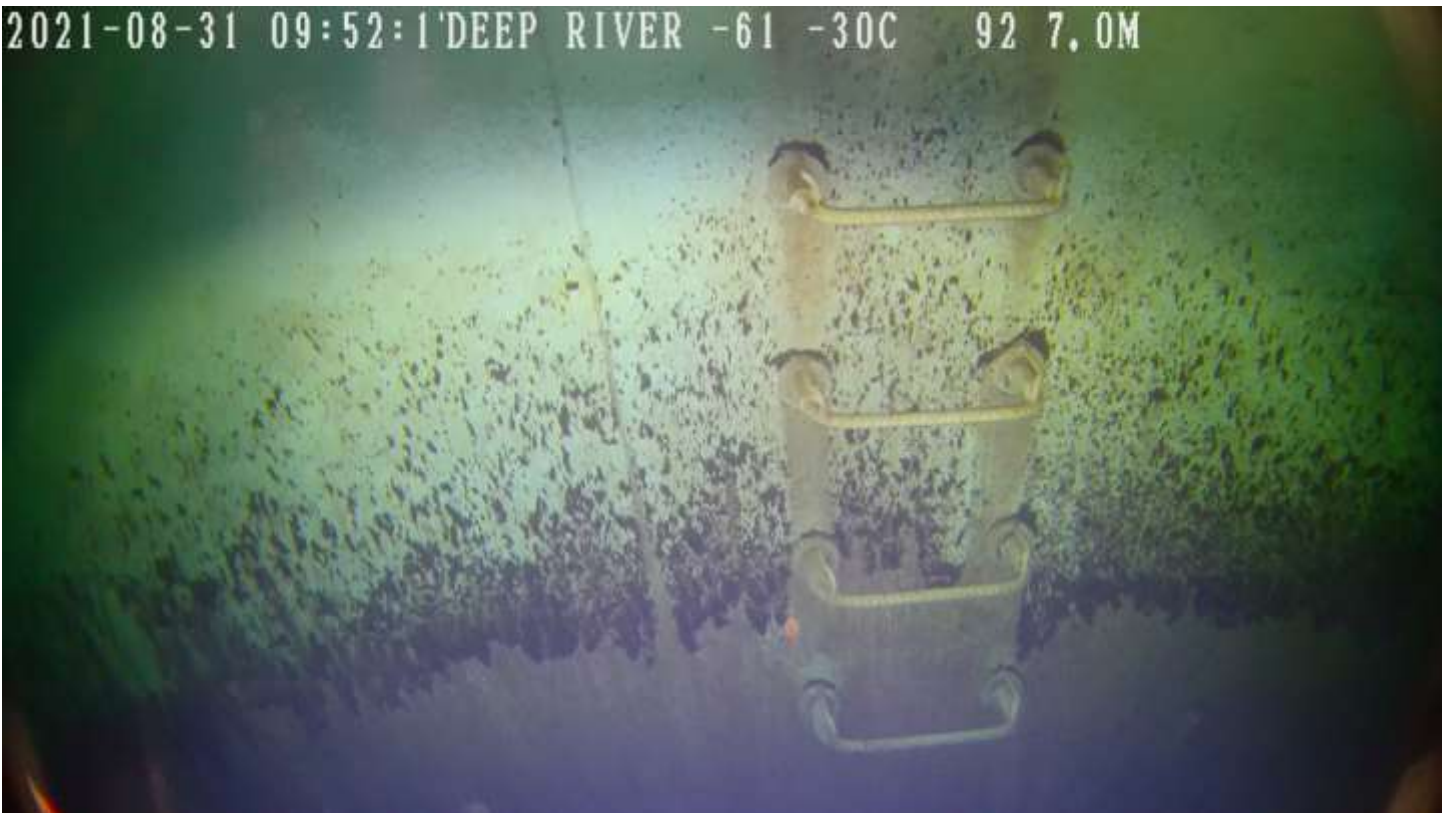
Video Image #15 – Deep River Multi-Leg Potable Water Tower – **Below the Waterline** – Lower Shell Area. (Video Image enhanced – brightness & Contrast, to make lining defects stand out). Generally, the lining system on the shell area of the Deep River Tower appears to be in good condition. Same as previous video image. Platform mainway ladder rungs appear to be intact at this time. Note the sediment from the bowl area.

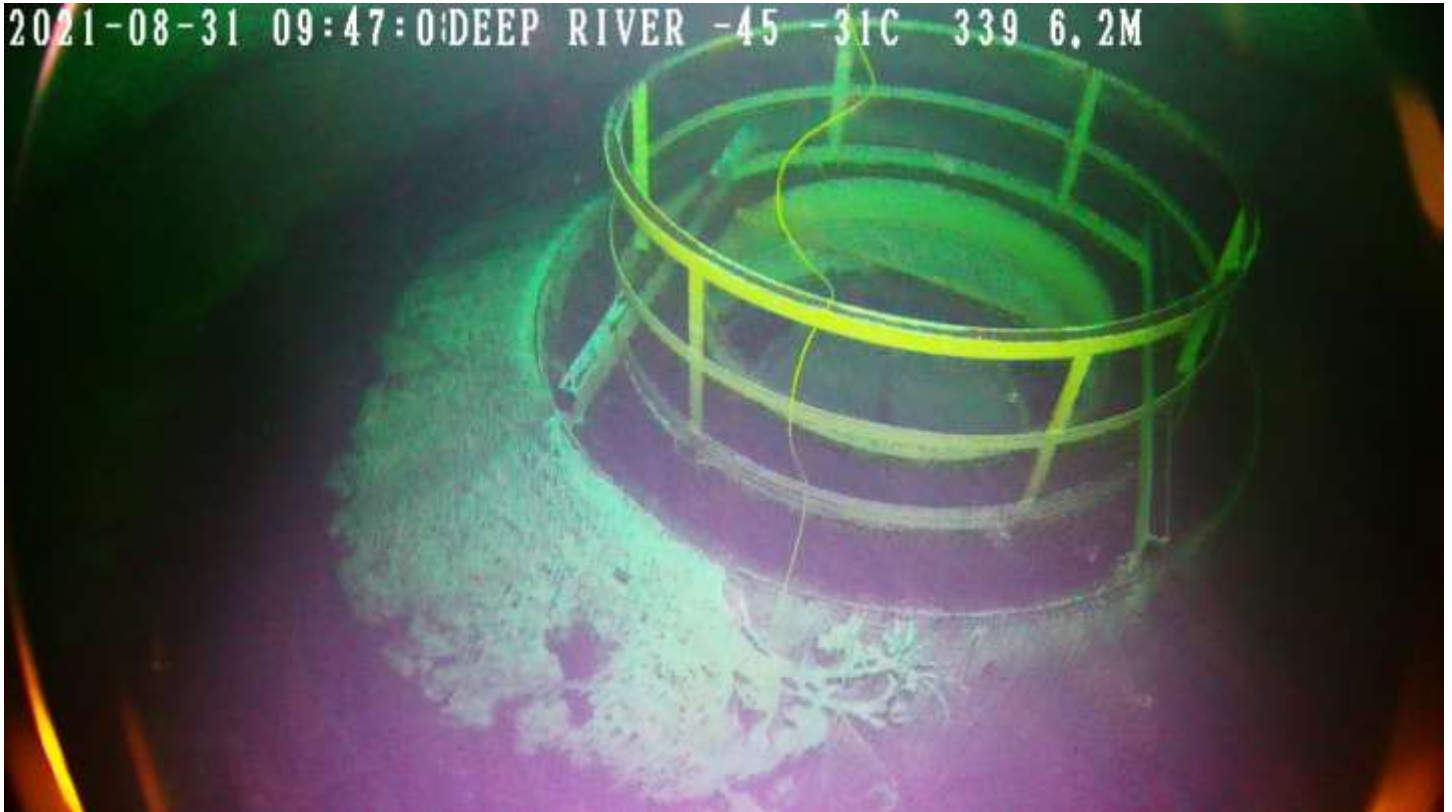
Video Image #16 – Deep River Multi-Leg Potable Water Tower – **Below the Waterline** – Lower Shell Area. (Video Image enhanced – brightness & Contrast, to make lining defects stand out). Center riser and floor bowl area. Bowl coating system could not be evaluated due to the sediment on the bowl floor areas. Construction material or parts of a cathodic protection system was identified on the bowl floor area.

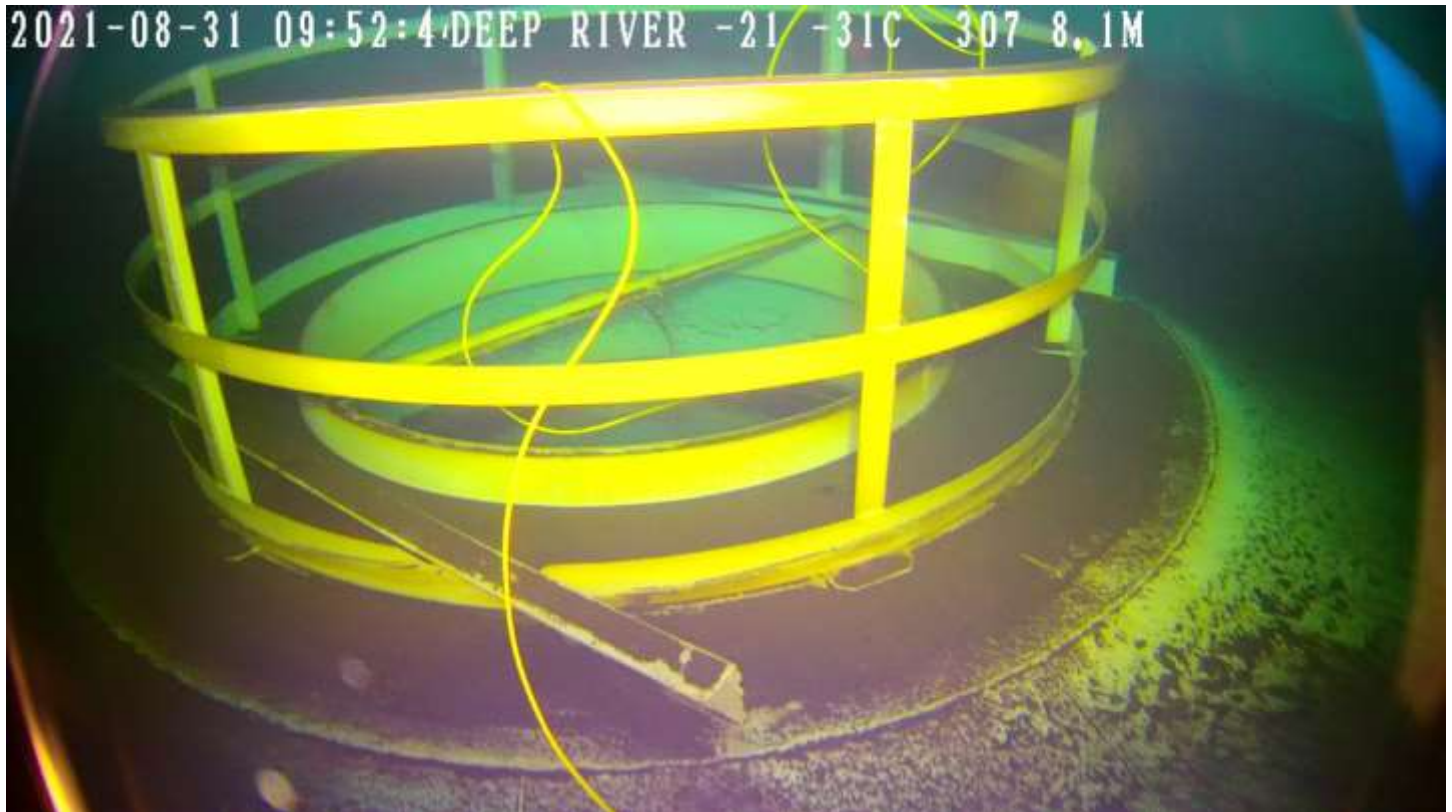
Video Image #17 – Deep River Multi-Leg Potable Water Tower – **Below the Waterline** – Lower Shell Area. (Video Image enhanced – brightness & Contrast, to make lining defects stand out). Center riser and floor bowl area. Bowl coating system could not be evaluated due to the sediment on the bowl floor areas. Construction material or parts of a cathodic protection system was identified on the bowl floor area.

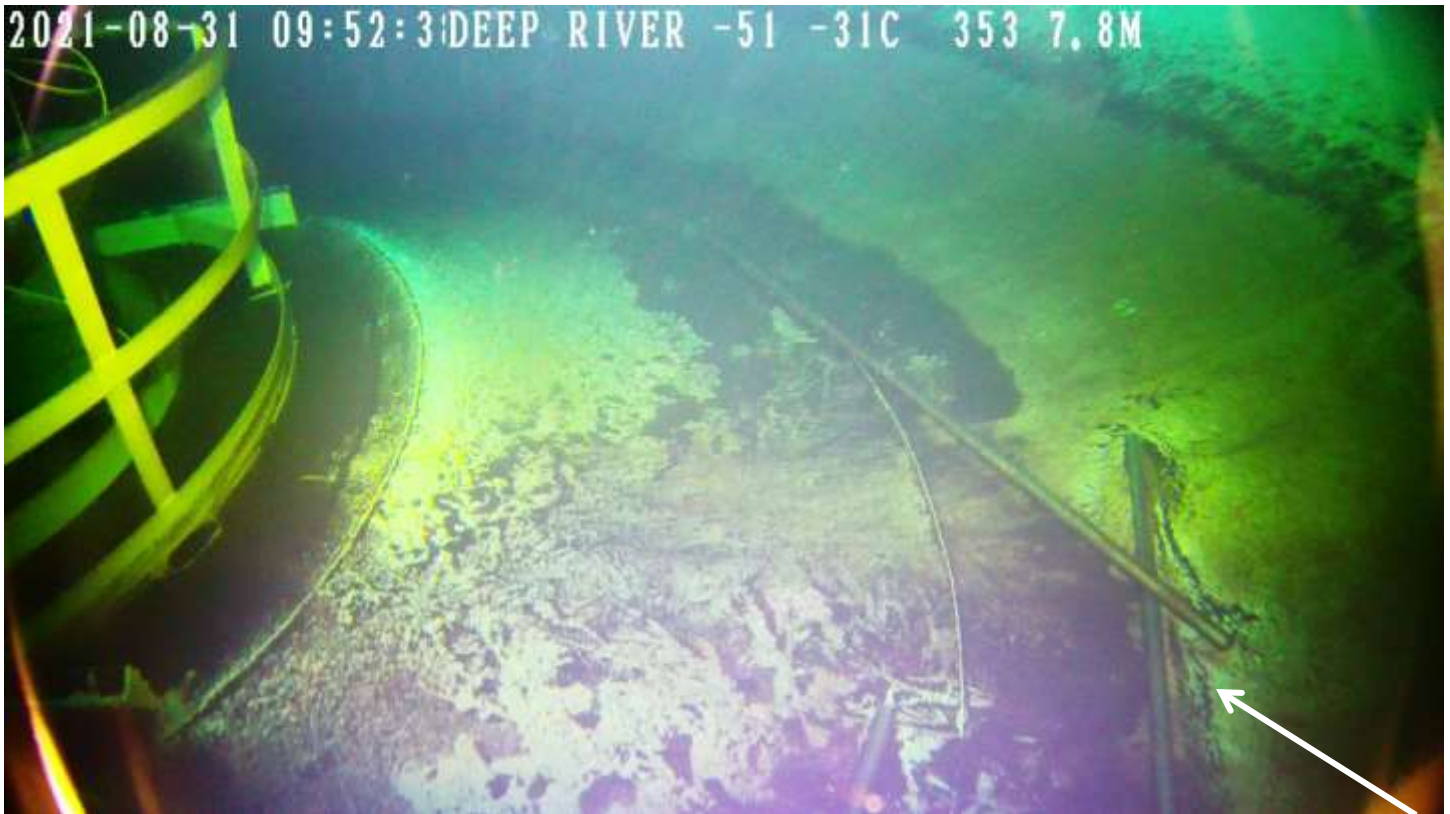
Video Image #18 – Deep River Multi-Leg Potable Water Tower – **Below the Waterline** – Lower Shell Area. (Video Image enhanced – brightness & Contrast, to make lining defects stand out). Center riser and floor bowl area. Bowl coating system could not be evaluated due to the sediment on the bowl floor areas. Construction material or parts of a cathodic protection system was identified on the bowl floor area.

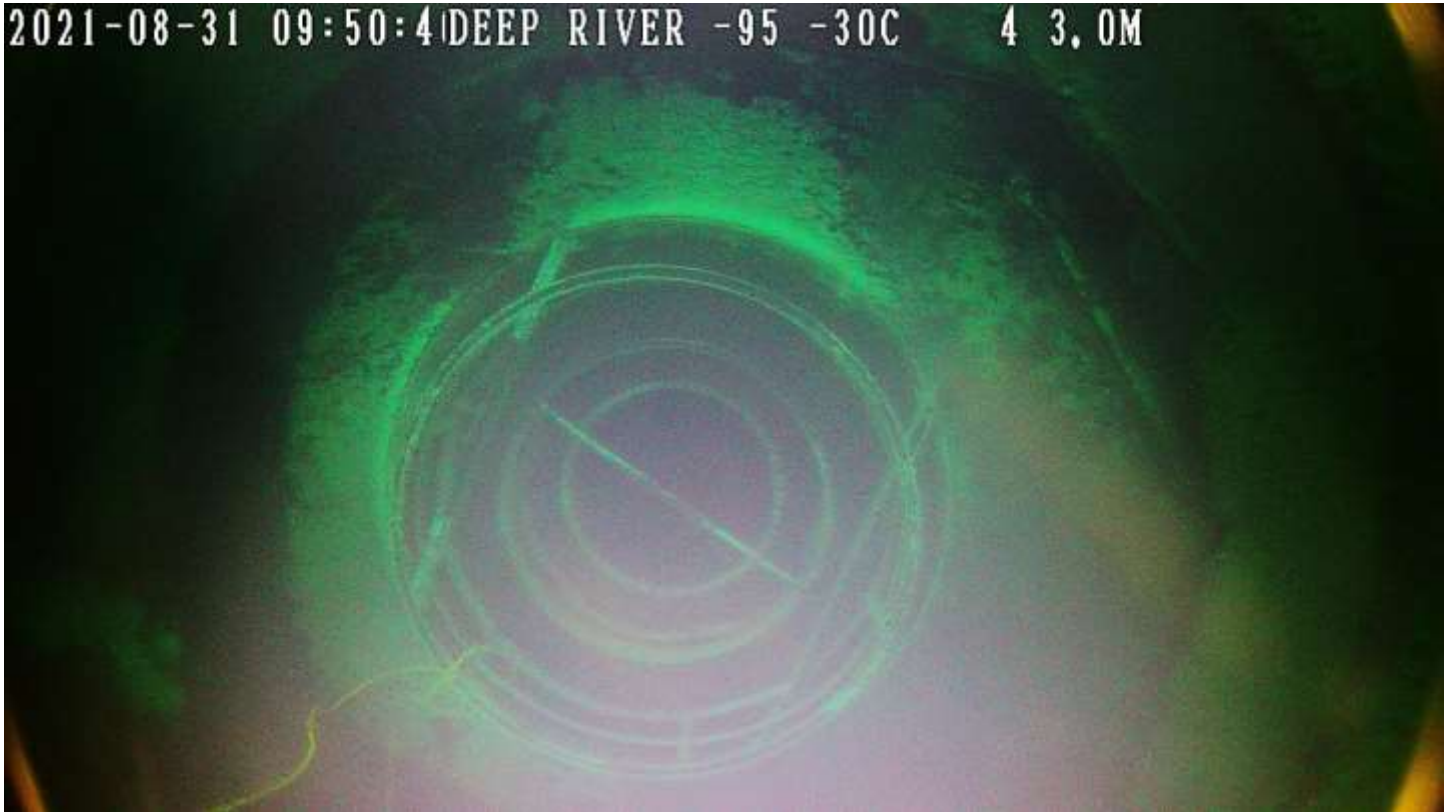
Video Image #19 – Deep River Multi-Leg Potable Water Tower – **Below the Waterline** – Lower Shell Area. (Video Image enhanced – brightness & Contrast, to make lining defects stand out). Center riser and floor bowl area. CCTV ROV looking down into the riser.
