Deep River 330,000 Gallon Elevated Water Tank Video Inspection

330,000 Gallon Capacity, Six Legged Structure, Elevated Tank

Town Of Deep River

Water Treatment Plant

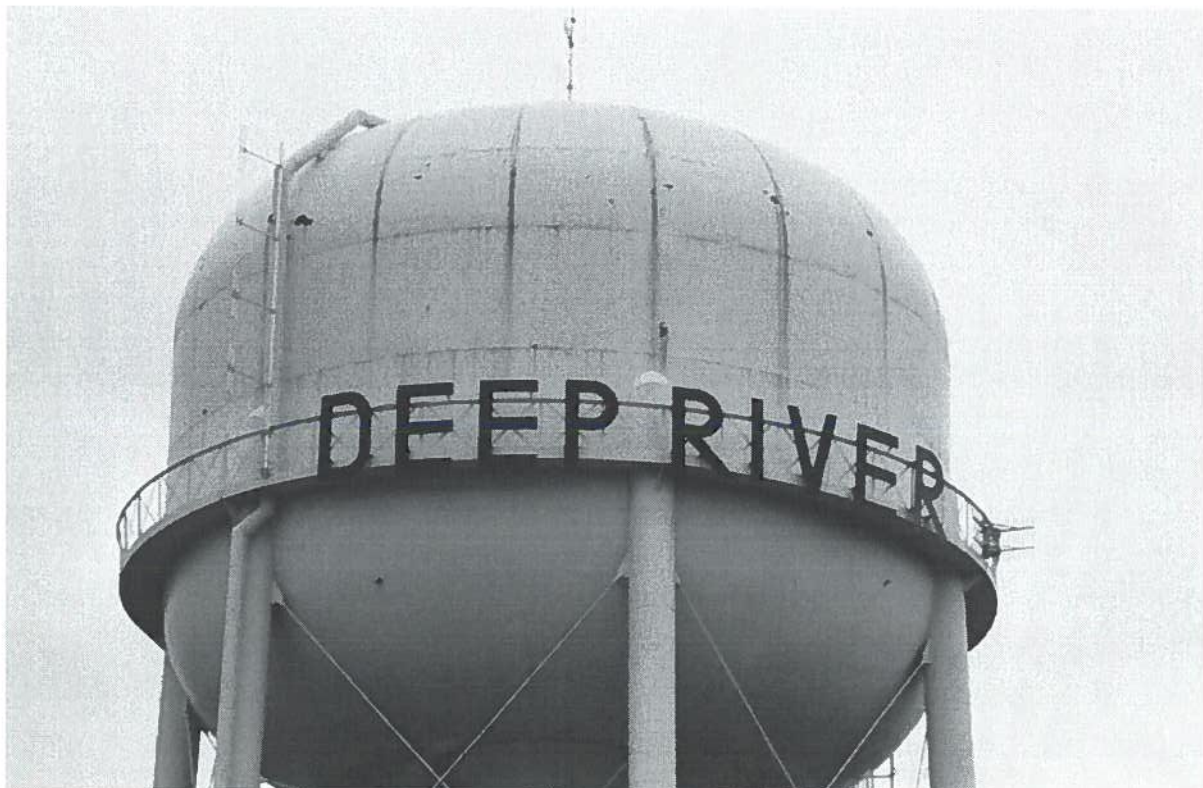
View of Tank Showing Some External Rust Deposits

- 5) Reinspect internally in two years to check on the progress of pitting and rust seen this time. Continue to monitor the tank externally until recoating is performed.

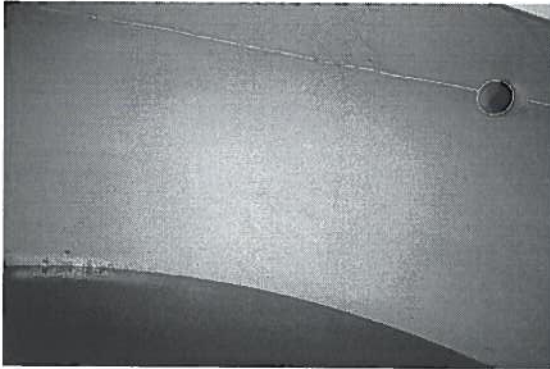
Wall, Overflow Pipe (see view in 2000)

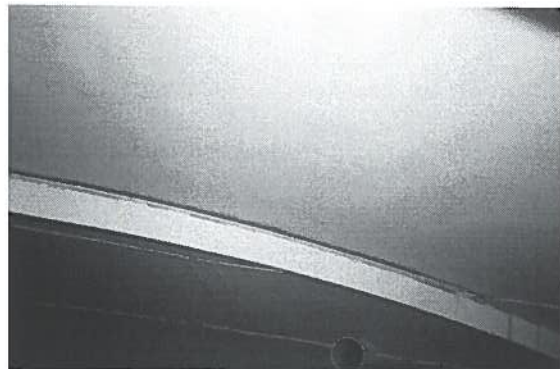
Roof Plate, Support Beam, Overflow Pipe

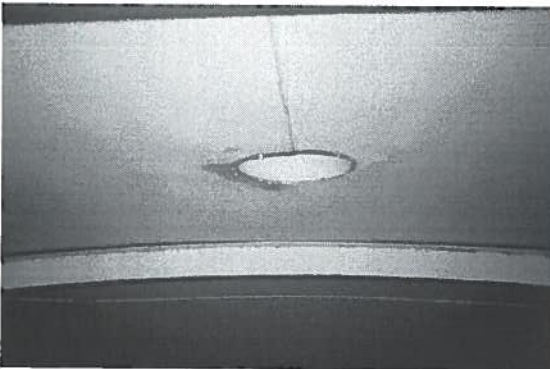
Underside of Roof Centre, Vent Opening

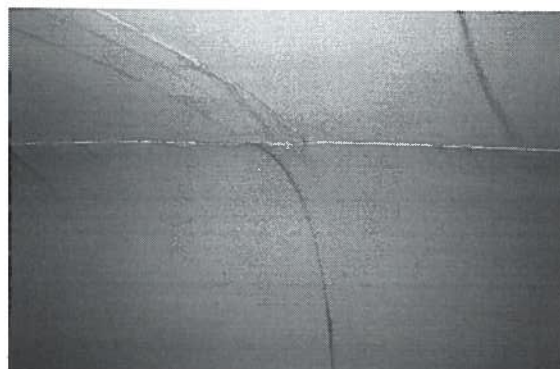
Roof to Wall Overlapping Steel Plating

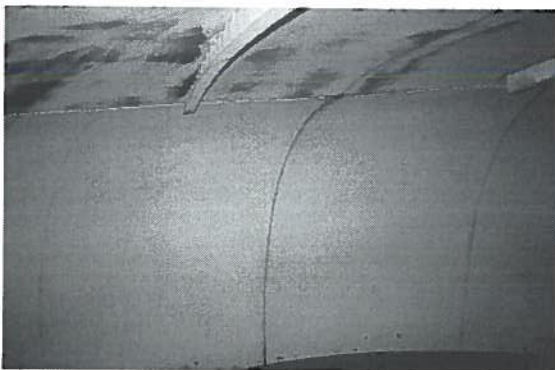
- 1) Random pitting corrosion and small areas of rust deposits were seen on the walls and some welds. No large areas of coating failure or corrosion were seen except on the underside of the roof there is an area of rust beginning to show – see photo.

Underside of Roof Looking Approx. South
Area Beginning to Rust is Seen on Video

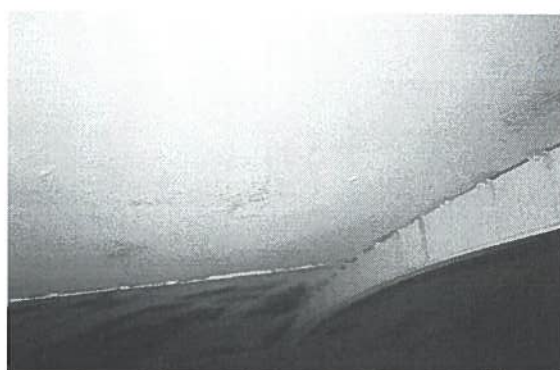
Underside of Roof Above Photo at Left
All Internal Photos Taken from Hatchway

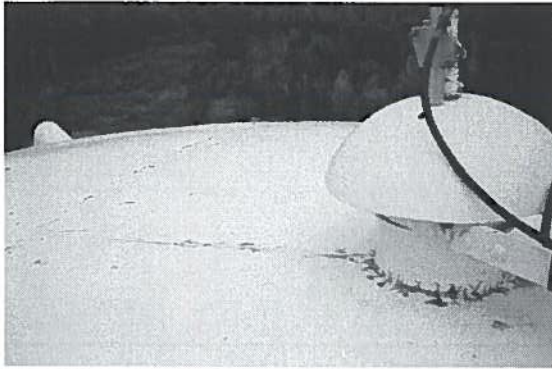
Roof Vent Cap (see view in 2000)

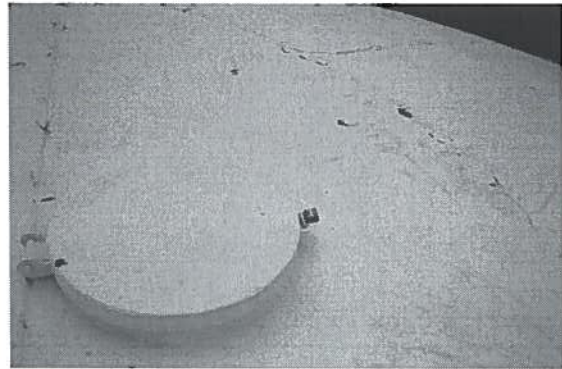
- 6) After the video inspection was completed, the roof top manway lid was closed and secured using a replacement “Master Lock” padlock and the only copy of the key was given to OCWA personnel.

Hatch Secured and Locked after Inspection

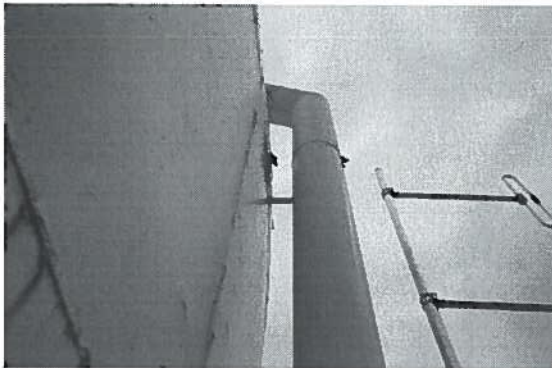
Overflow, Cracked Support Weld (see 2000)

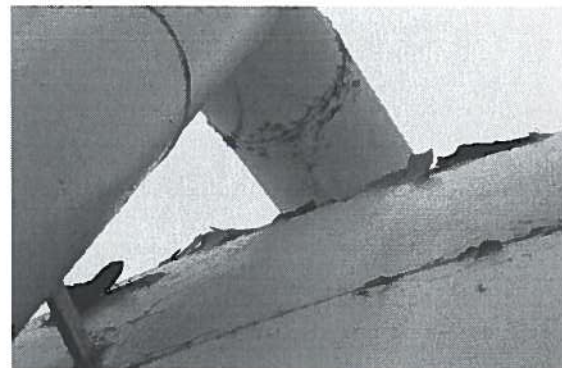
External Paint Flaking Off near Overflow

- 3) If and when any external recoating of the tank is performed, ensure that internal touch-ups or weld repairs have been completed prior to going ahead with external painting. Ensure that inspection performed after sand-blasting and prior to recoating is performed by qualified personnel.

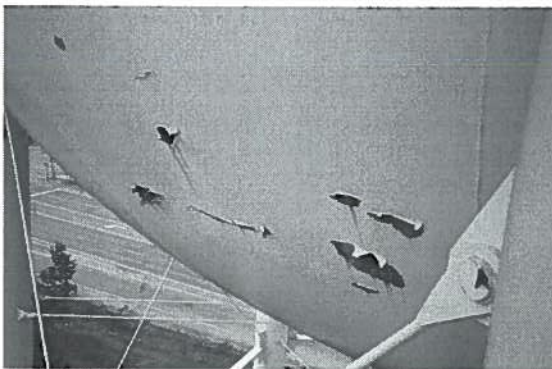
Lower West of Tank Areas of Coating Off,
Three Spots of Coating Off Here in 2000

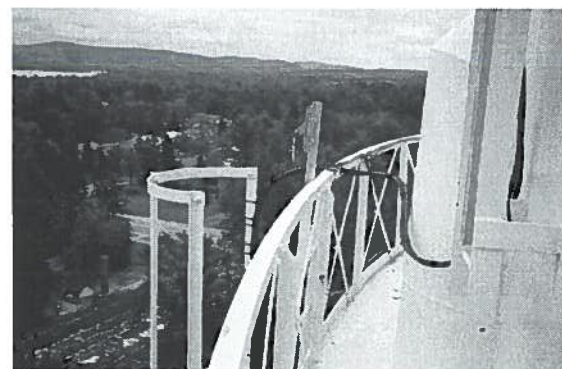
- 2) There is light, brown-coloured sediment on the lower and floor areas of the tank typically seen in most potable water storage facilities.
- 3) The fall-arrest system on the domed roof has missing fasteners and the main fall-arrest rail up the vertical access ladder is open-ended at the top.

Top of Long Fall-Arrest Rail Centre of Photo
& Loose Fall-Arrest Rail on Right at Tank

- 4) Install an approved “spring-loaded” stop at the top of the main fall-arrest rail to ensure that persons can safely move from the ladder to the catwalk. Install more fasteners as required on the lower portion of the fall-arrest rail on the domed roof.
