**LMS Job # LM3102: Inspection and Repair:**  
**Deep River Multi-Legged Elevated Tank; Potable Water Storage Facility**

**MULTI - LEGGED INSPECTION REPORT**

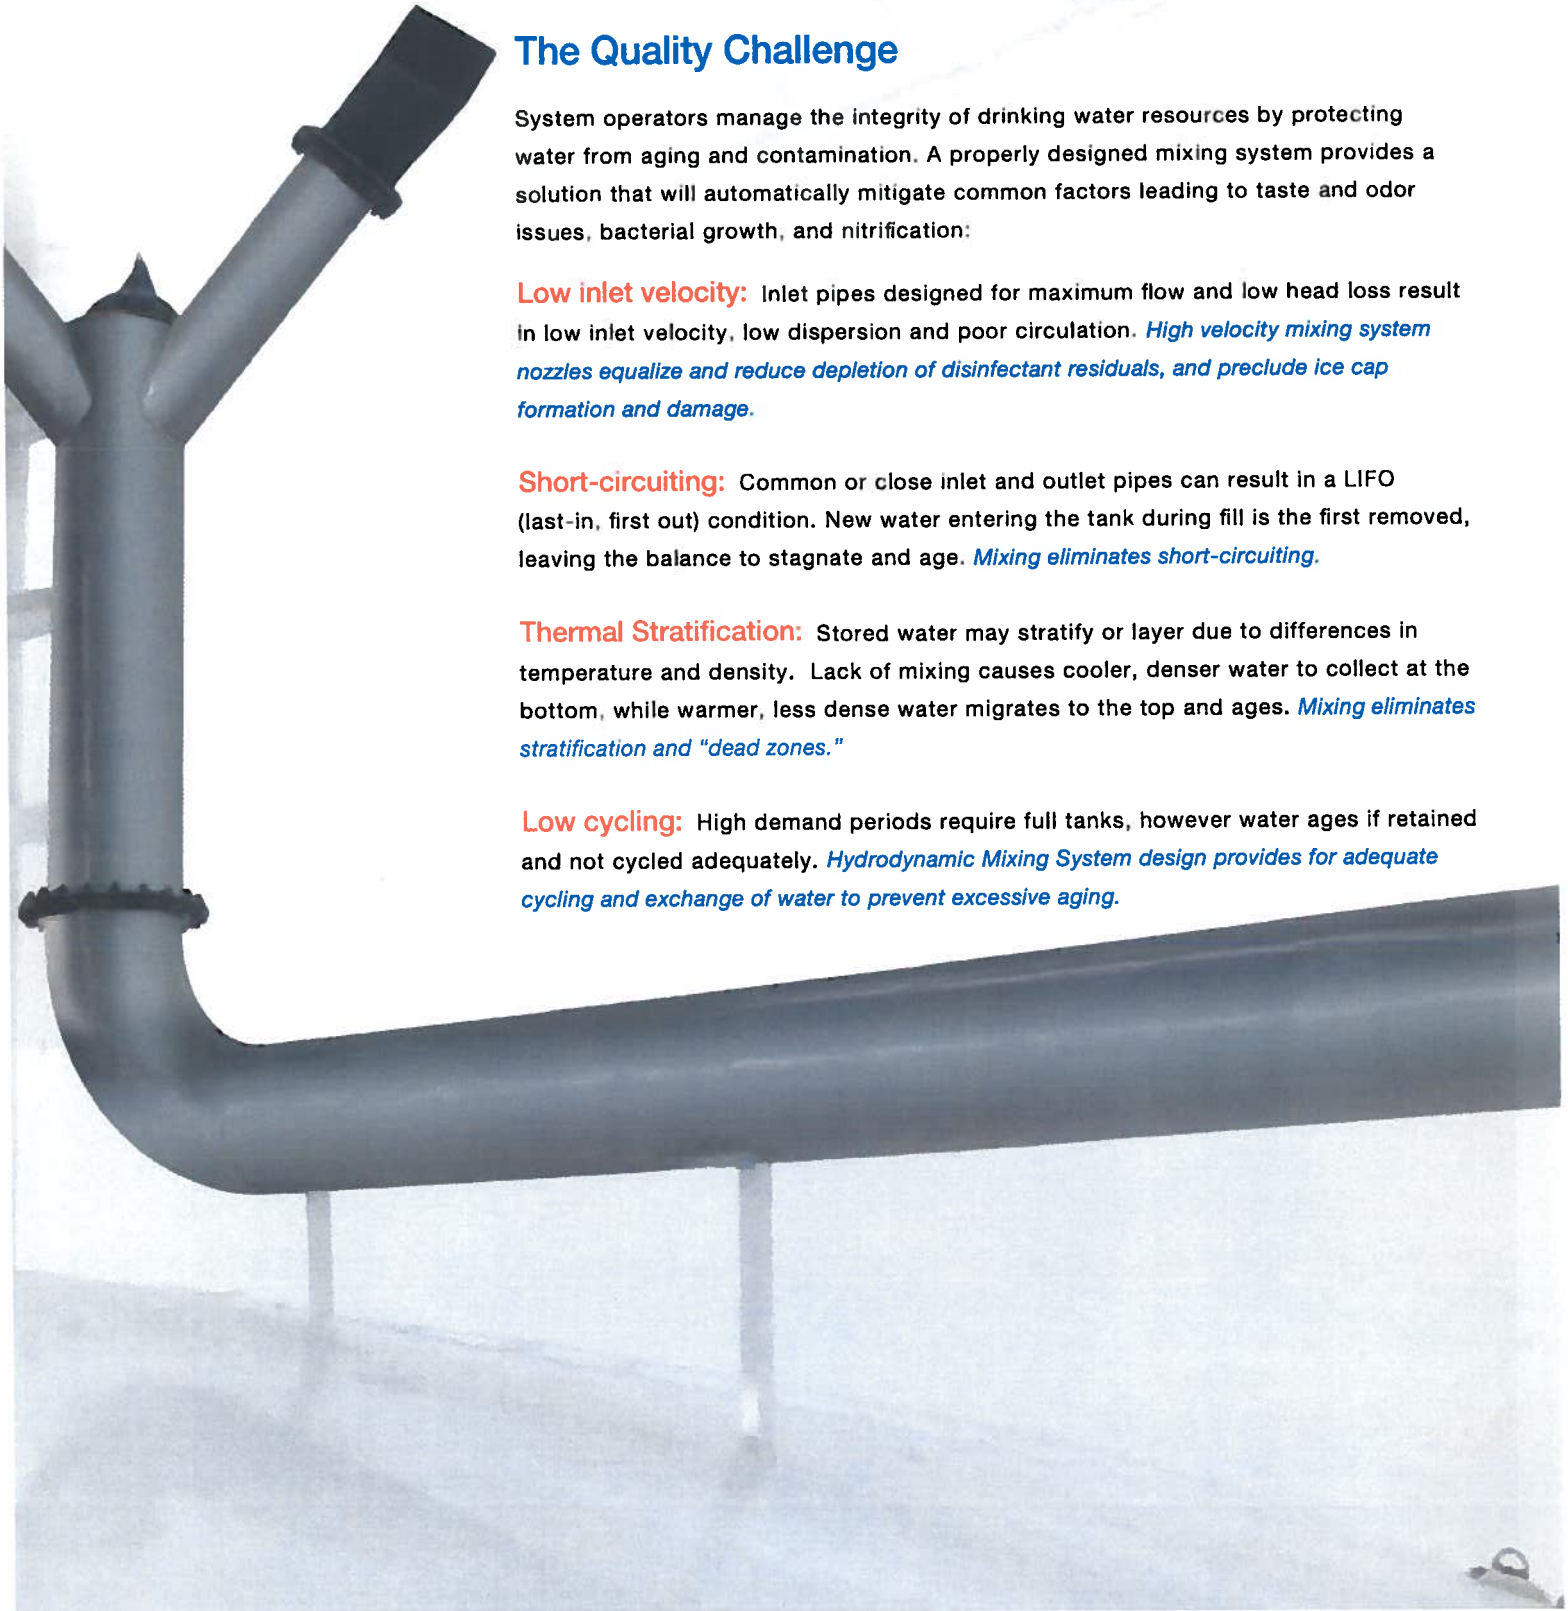
**Low inlet velocity:** Inlet pipes designed for maximum flow and low head loss result in low inlet velocity, low dispersion and poor circulation. *High velocity mixing system nozzles equalize and reduce depletion of disinfectant residuals, and preclude ice cap formation and damage.*

**Short-circuiting:** Common or close inlet and outlet pipes can result in a LIFO (last-in, first out) condition. New water entering the tank during fill is the first removed, leaving the balance to stagnate and age. *Mixing eliminates short-circuiting.*

**Thermal Stratification:** Stored water may stratify or layer due to differences in temperature and density. Lack of mixing causes cooler, denser water to collect at the bottom, while warmer, less dense water migrates to the top and ages. *Mixing eliminates stratification and "dead zones."*

**Low cycling:** High demand periods require full tanks, however water ages if retained and not cycled adequately. *Hydrodynamic Mixing System design provides for adequate cycling and exchange of water to prevent excessive aging.*

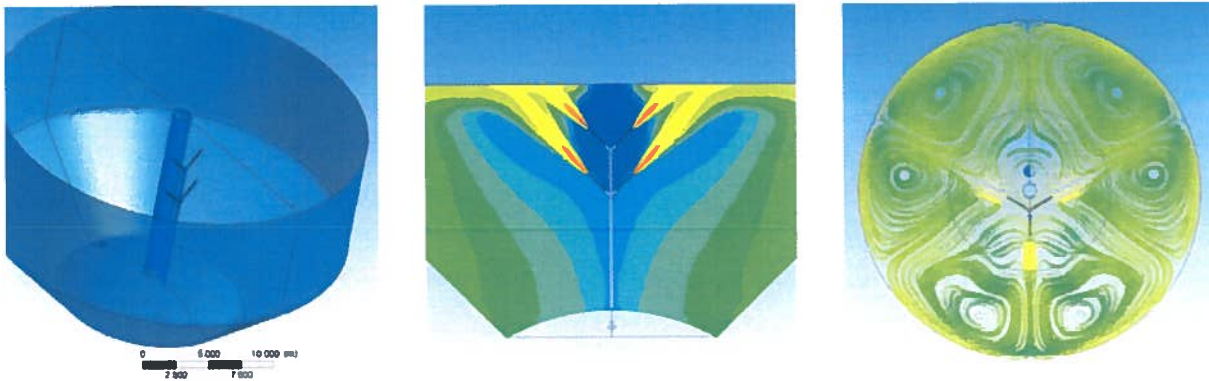
### Mixing System Function

- Manifold piping, inlet nozzle and outlet port combination utilizes energy of system operation to achieve complete mixing—no external power source required
- Inlet nozzles with variable orifice elastomeric check valves provide turbulent flow and increased momentum flux—harnessing more mixing power
- Outlet ports with wafer check valves are separated from inlet nozzles to maintain circulation
